Acquiring Data and Developing Applications for Coastal Zone Studies and Emergency Response

Gordon Wells

**XIII Brazilian Remote Sensing Symposium
Florianopolis, Santa Catarina, Brazil**

April 25, 2007

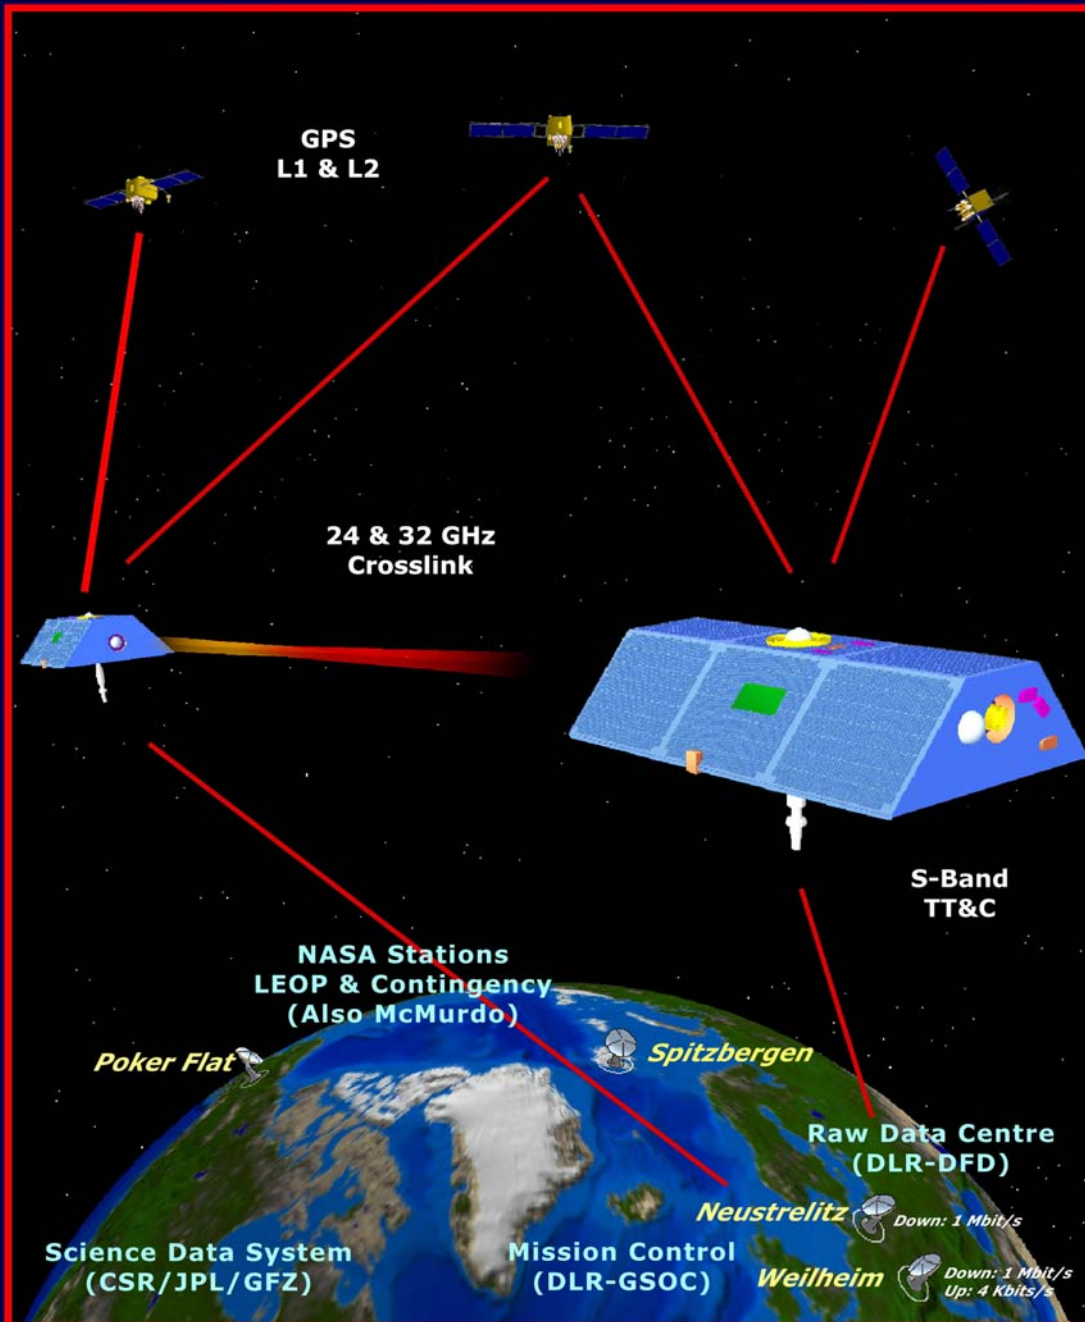
GRACE Mission

High resolution, mean & time variable gravity field mapping for Earth System Science applications.

- HAIRS (JPL/SSL/APL)
- SuperSTAR (ONERA)
- Star Cameras (DTU)
- GPS Receiver (JPL)

Launched: March 17, 2002

Initial Altitude: 500 km

Inclination: 89 deg

Eccentricity: ~0.001

Separation Distance: ~220 km

Non-Repeat Ground Track, Earth
Pointed, 3-Axis Stable

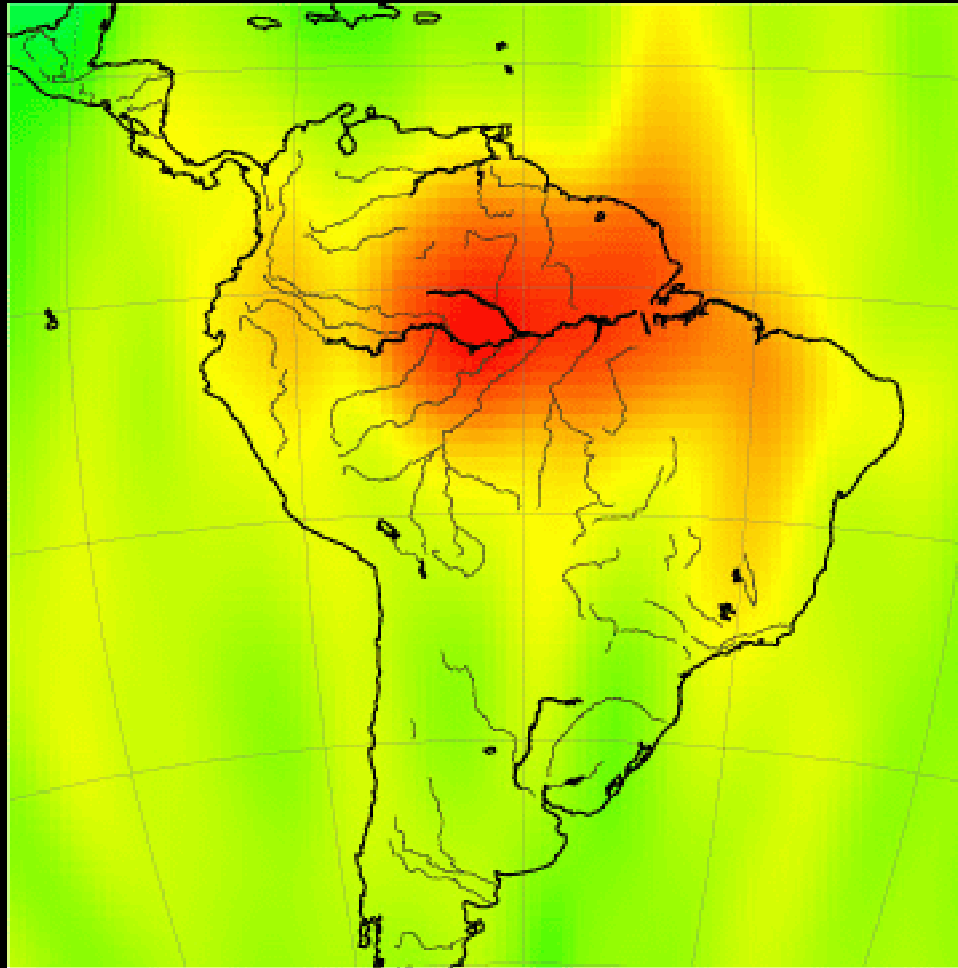
March 2003

Seasonal Variation in Geoid Height Measured by GRACE

Geoid Height Anomaly (mm)

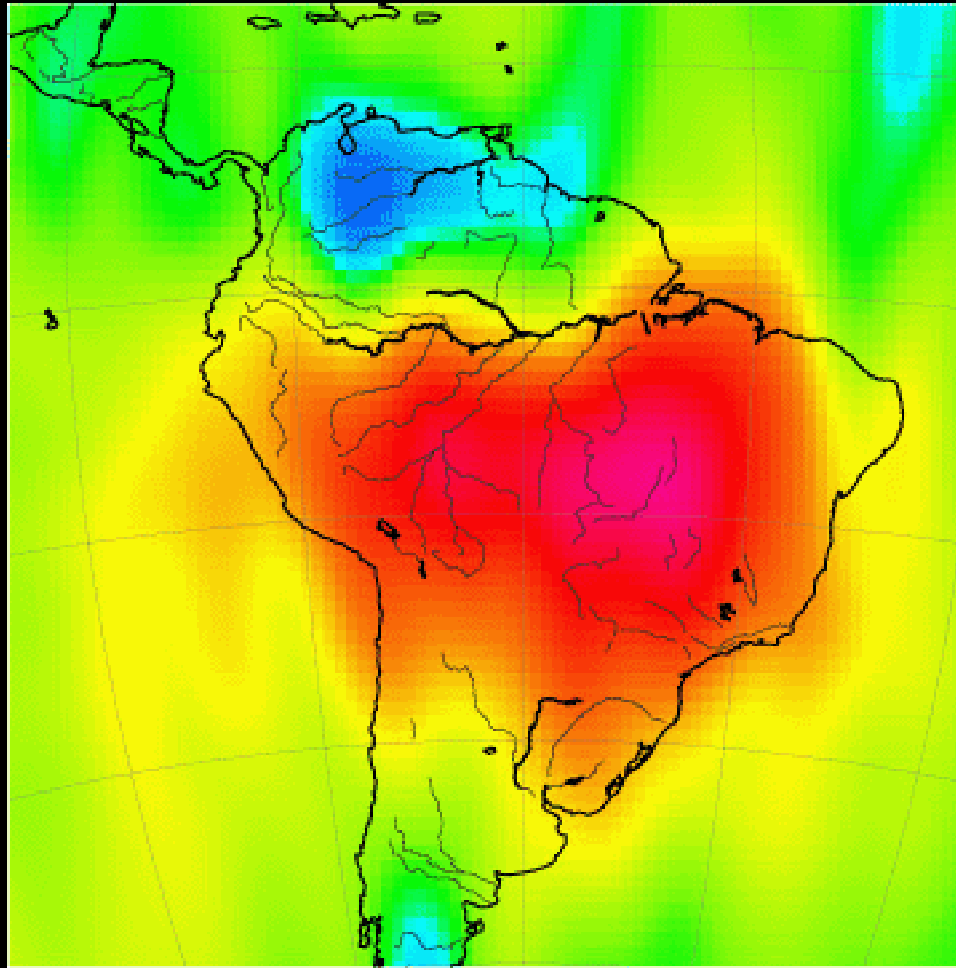
May 2003

Seasonal Variation in Geoid Height Measured by GRACE

Geoid Height Anomaly (mm)

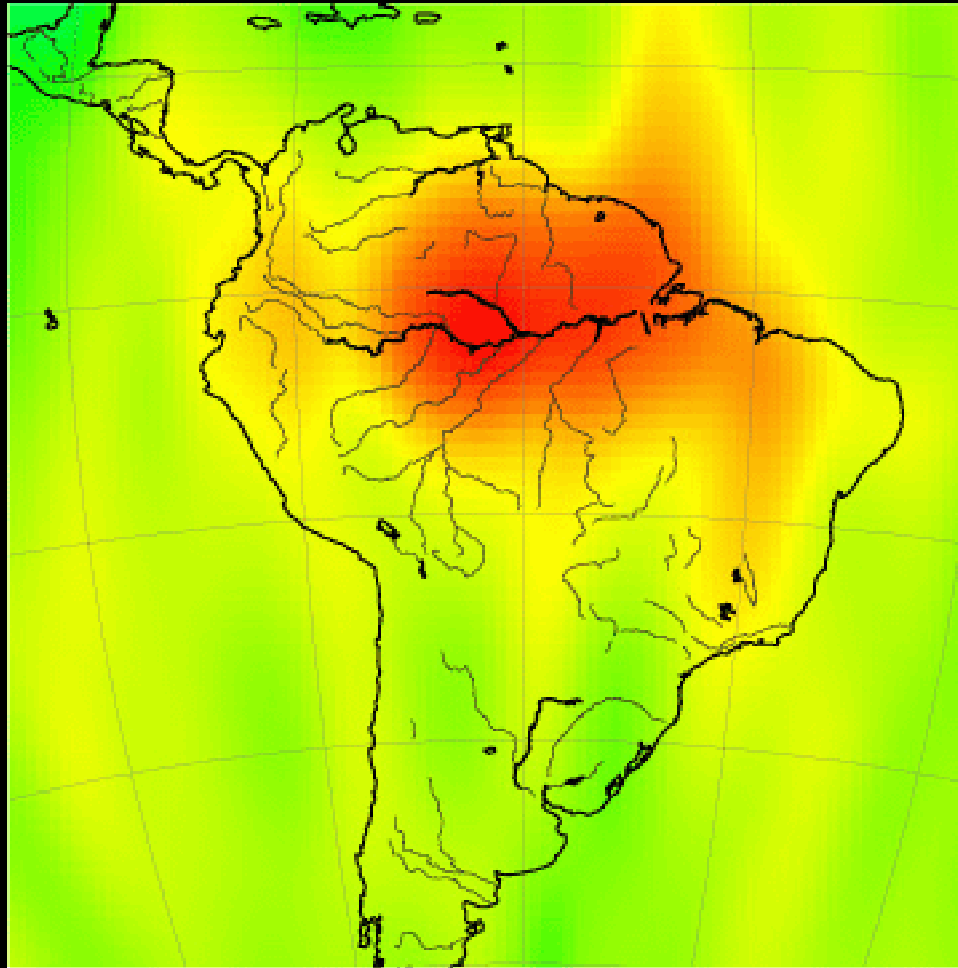
July 2003

Seasonal Variation in Geoid Height Measured by GRACE

Geoid Height Anomaly (mm)

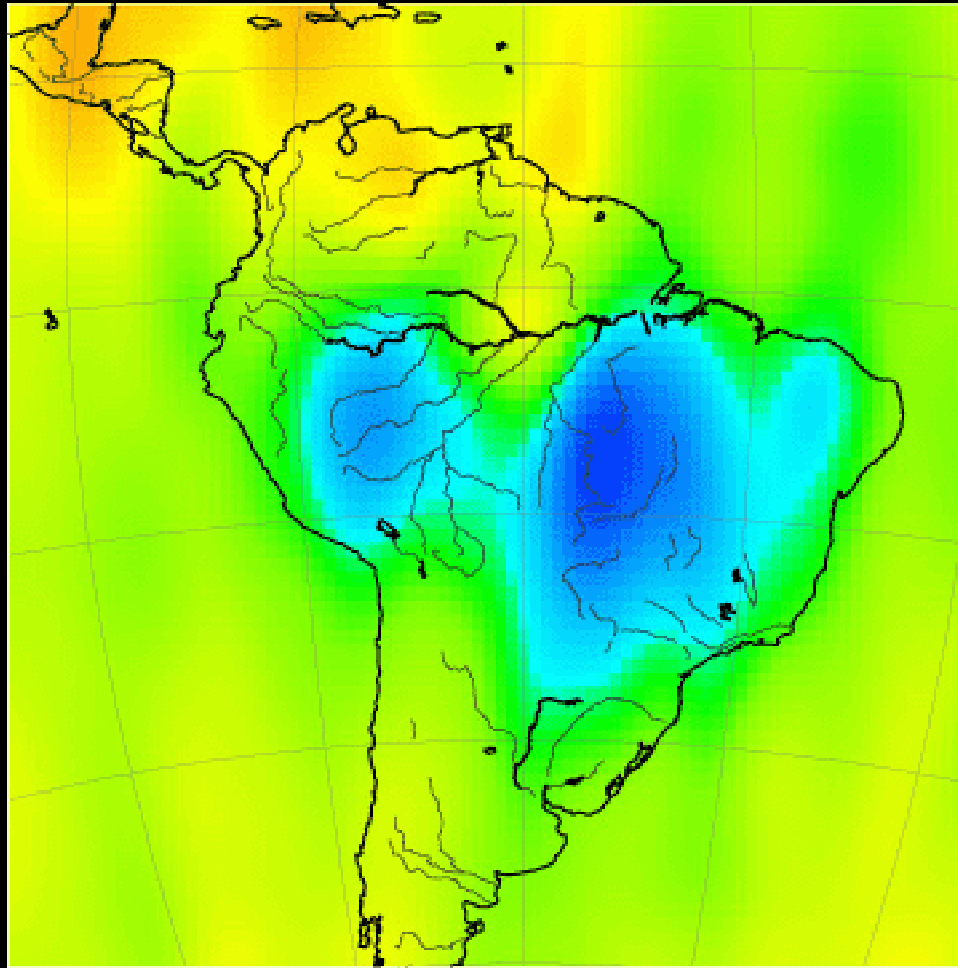
September 2003

Seasonal Variation in Geoid Height Measured by GRACE

Geoid Height Anomaly (mm)

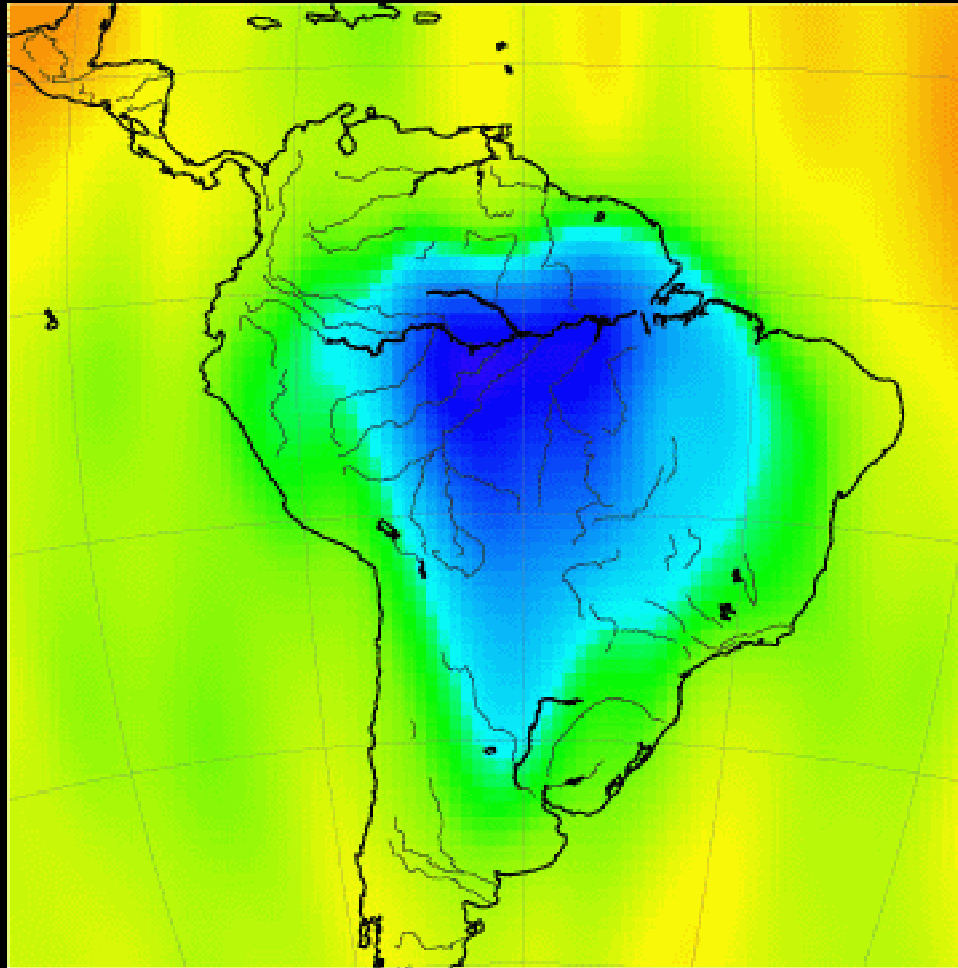
November 2003

Seasonal Variation in Geoid Height Measured by GRACE

Geoid Height Anomaly (mm)

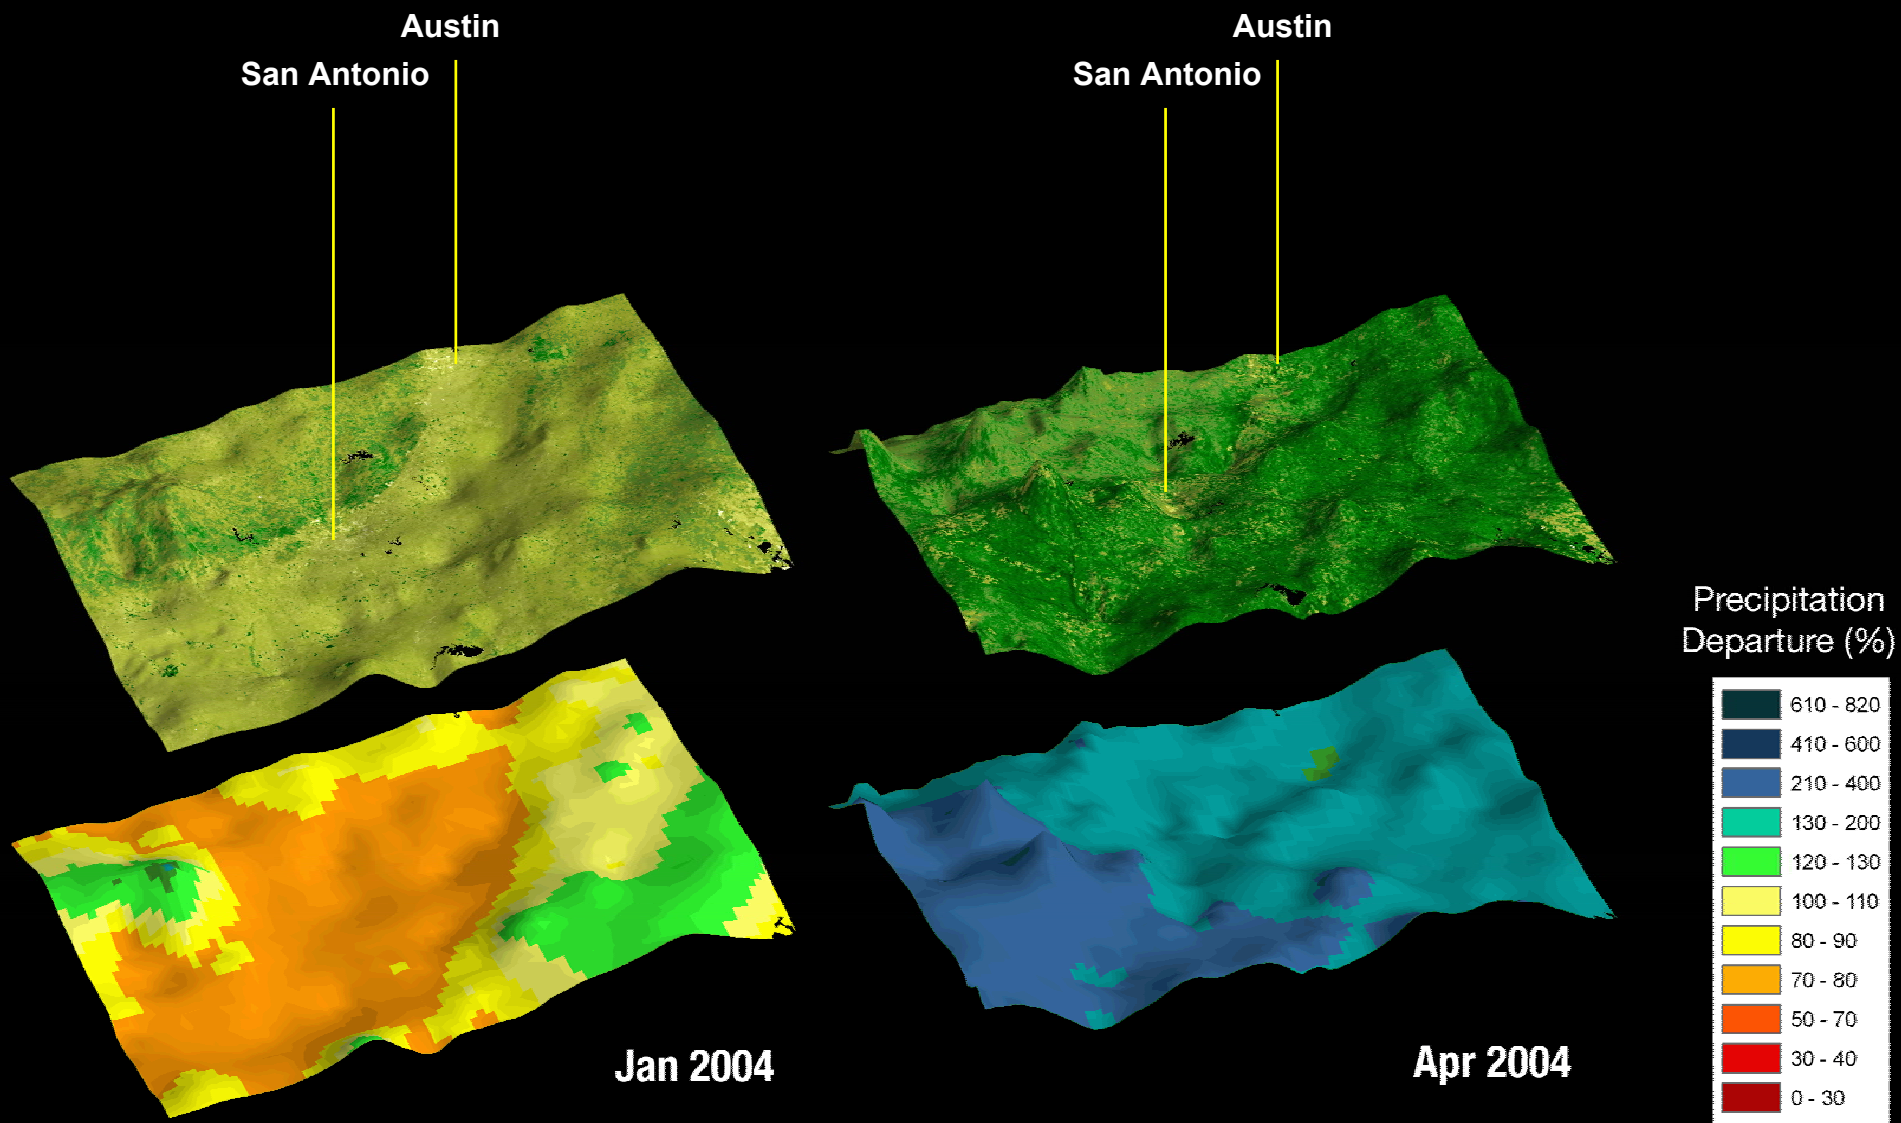
A comparison of Terra MODIS-derived NDVI images (top) from Central Texas and related normalized precipitation departure grids (bottom) illustrates the greening of vegetation as the result of changing hydrological conditions. The monthly precipitation departure topologies serve as the surfaces for both the precipitation and NDVI overlays.

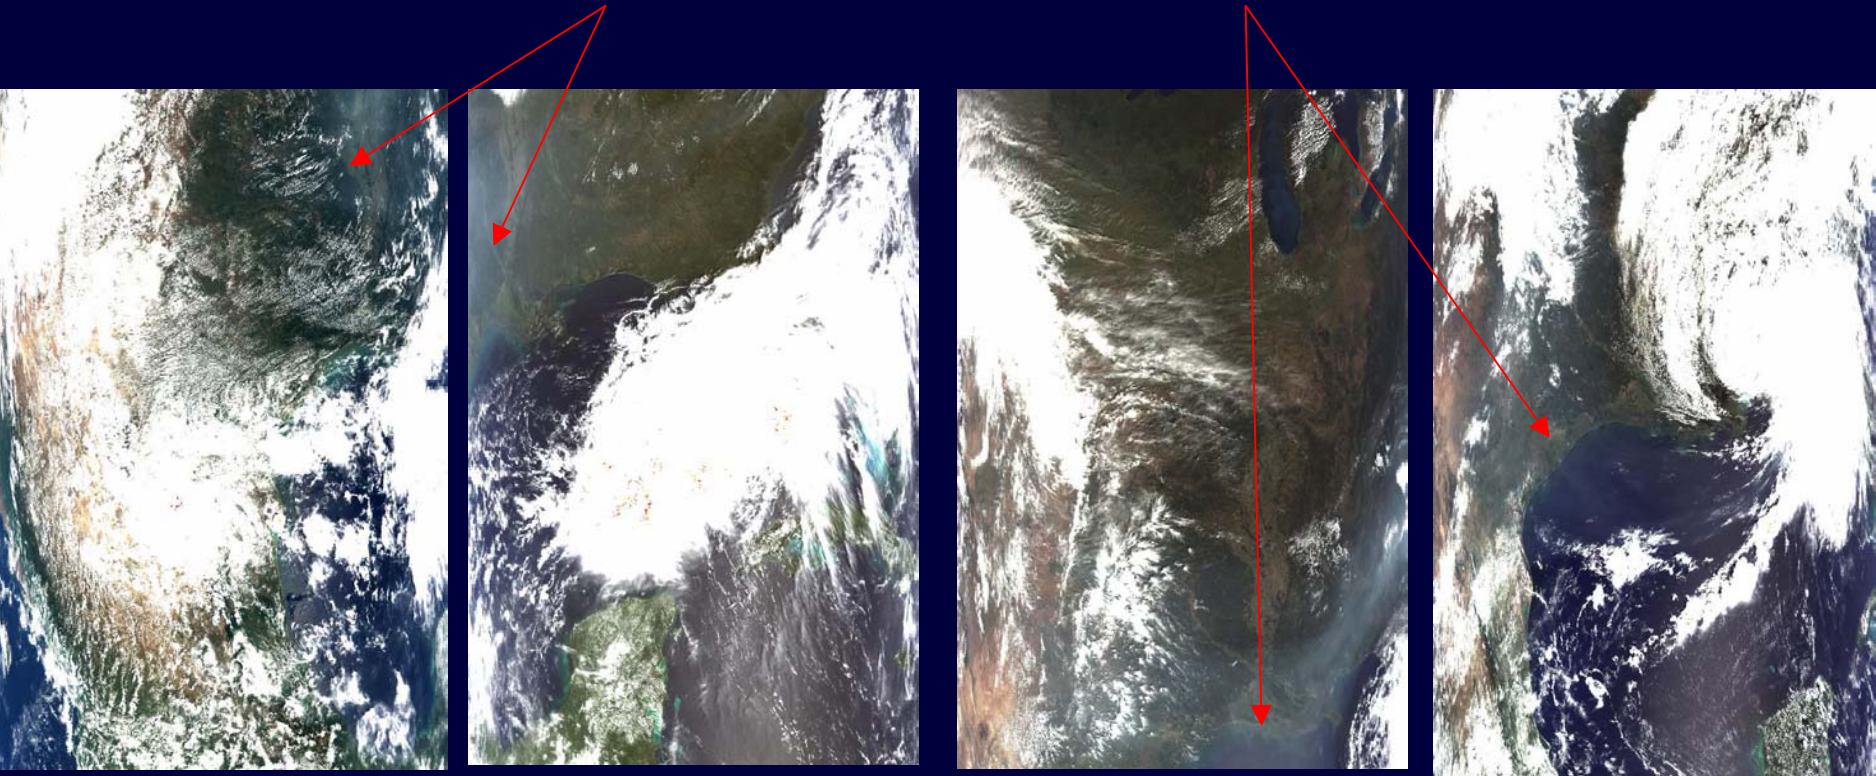
MODIS Imagery Proves Valuable for Monitoring Continental Haze Event*

Continental haze (ozone pollution) uniquely monitored in MODIS Imagery

* Hutchison, K. D., 2003: "Application of MODIS Data and Products for Air Quality Management across the State of Texas," **Atmospheric Environment** 37: 2403-2412.

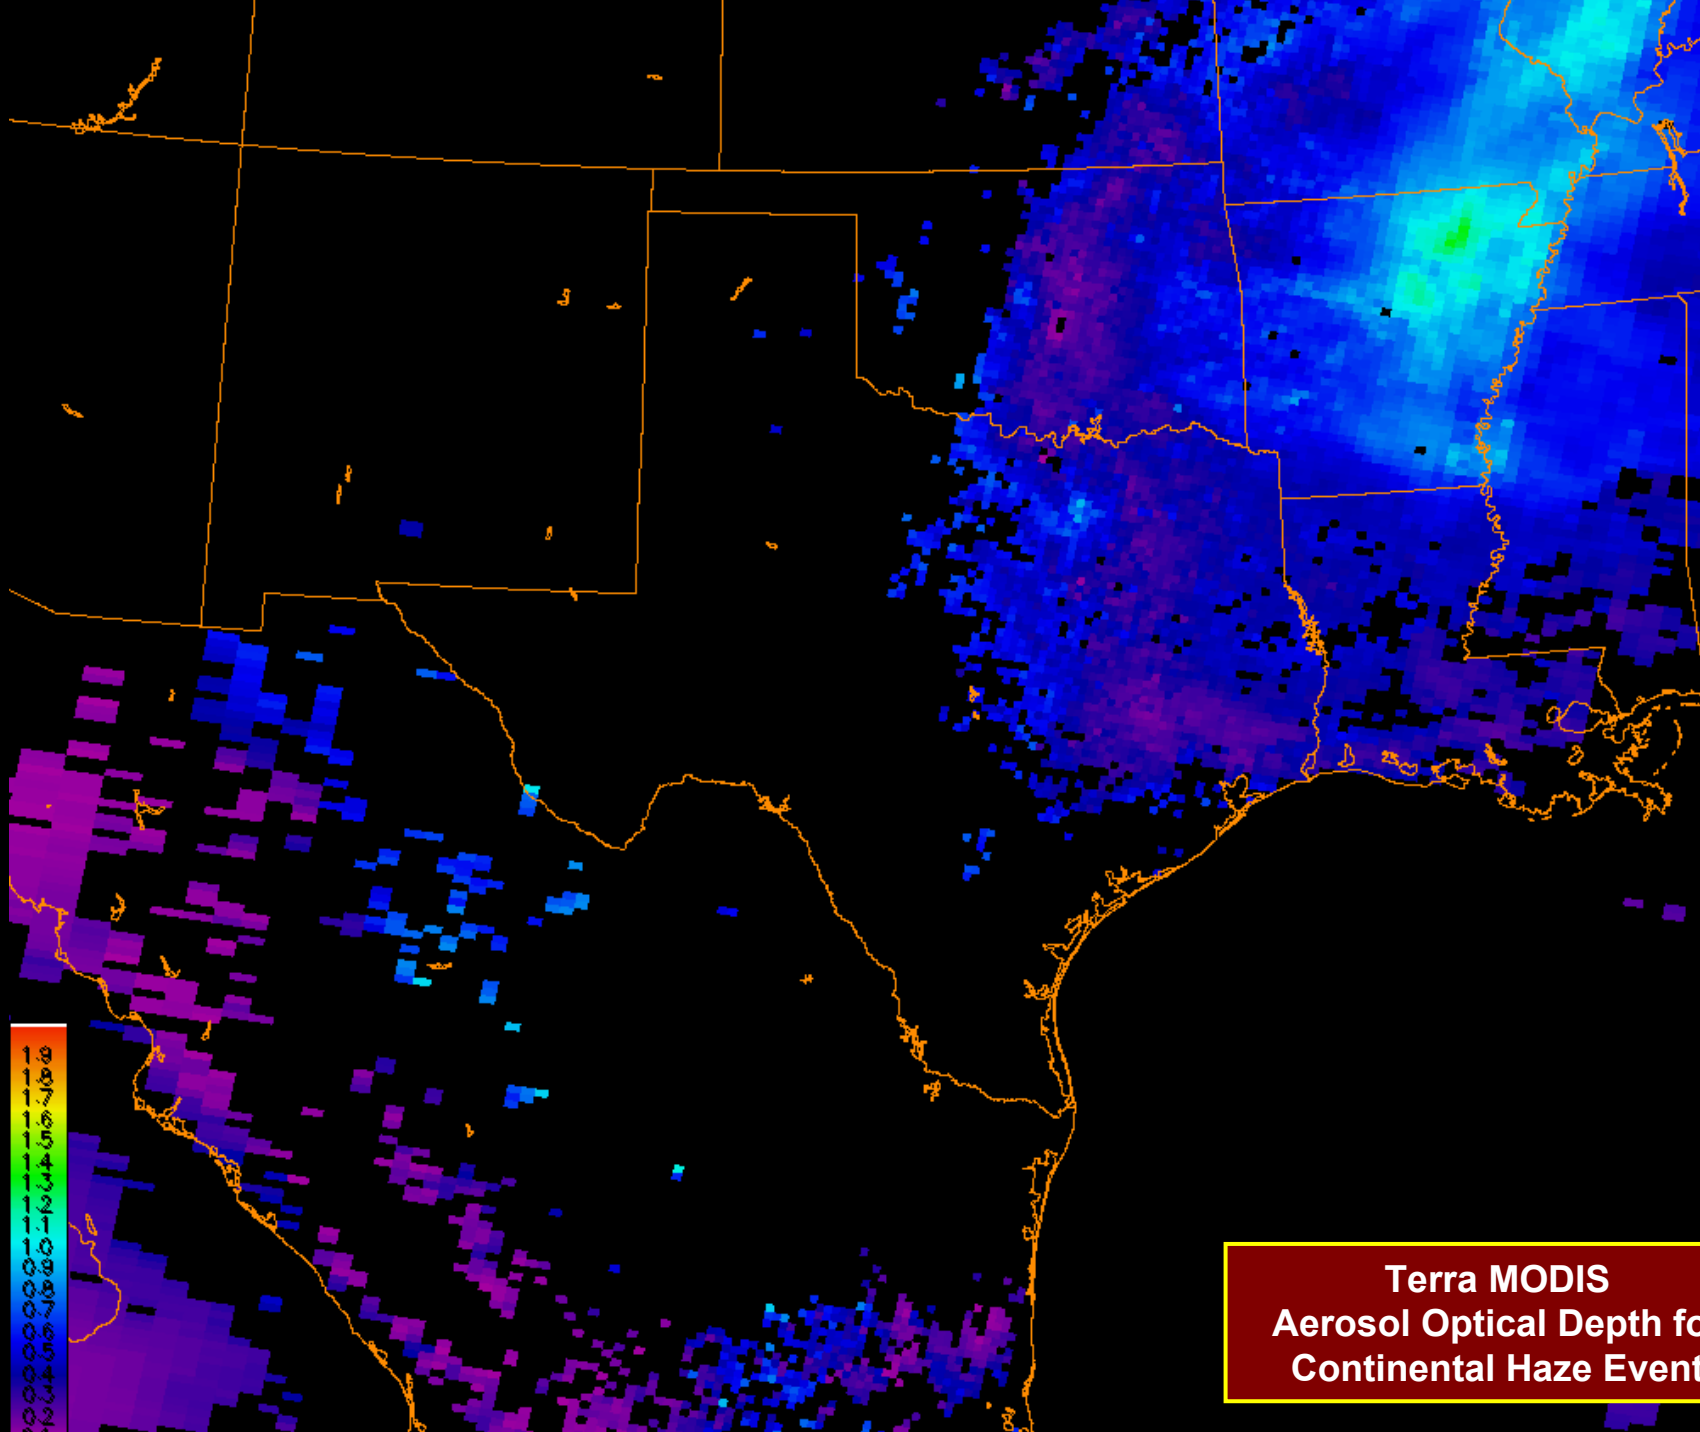
**Terra MODIS
Aerosol Optical Depth for
Continental Haze Event**

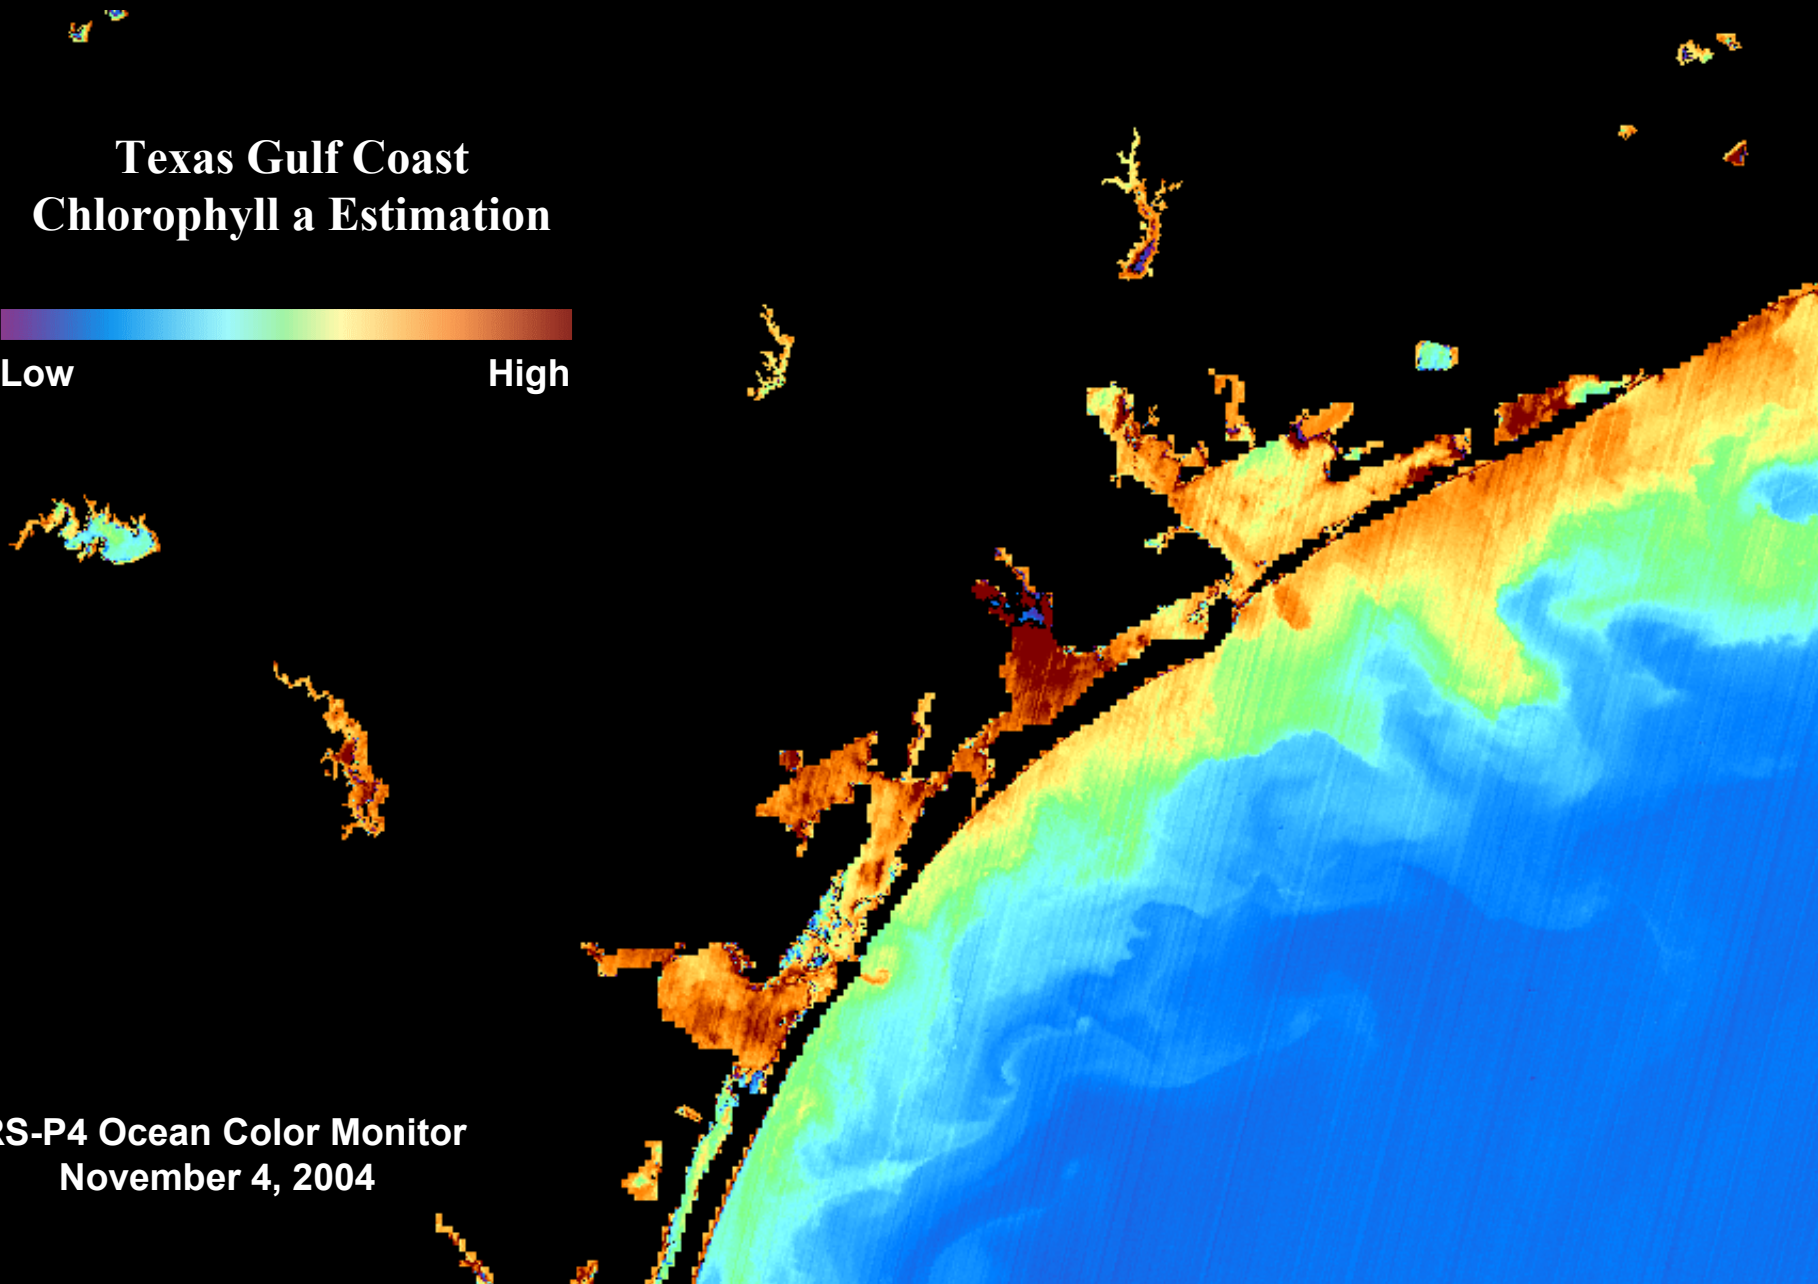
IRS-P4 Ocean Color Monitor
November 4, 2004

Texas Gulf Coast Chlorophyll a Estimation

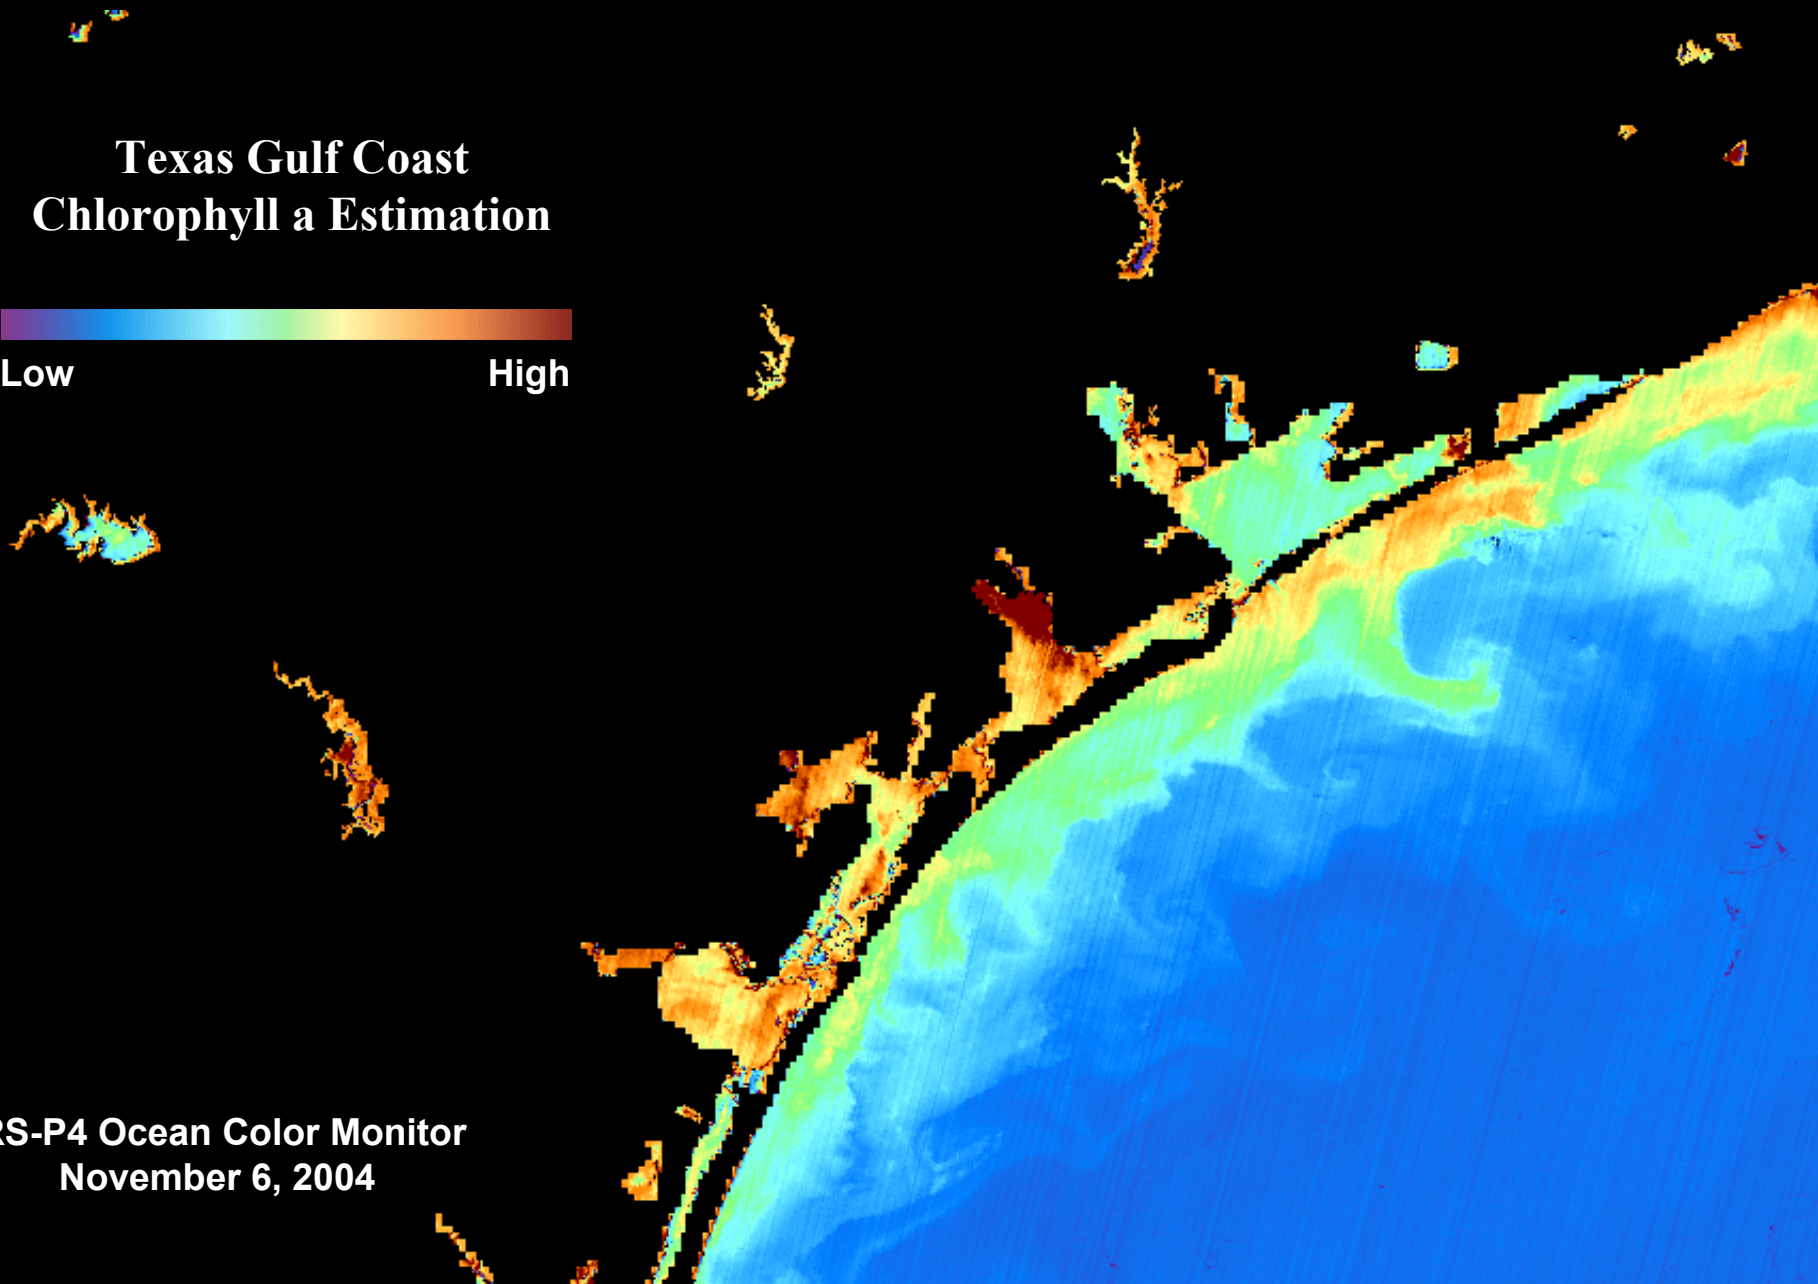
IRS-P4 Ocean Color Monitor
November 6, 2004

Texas Gulf Coast Chlorophyll a Estimation

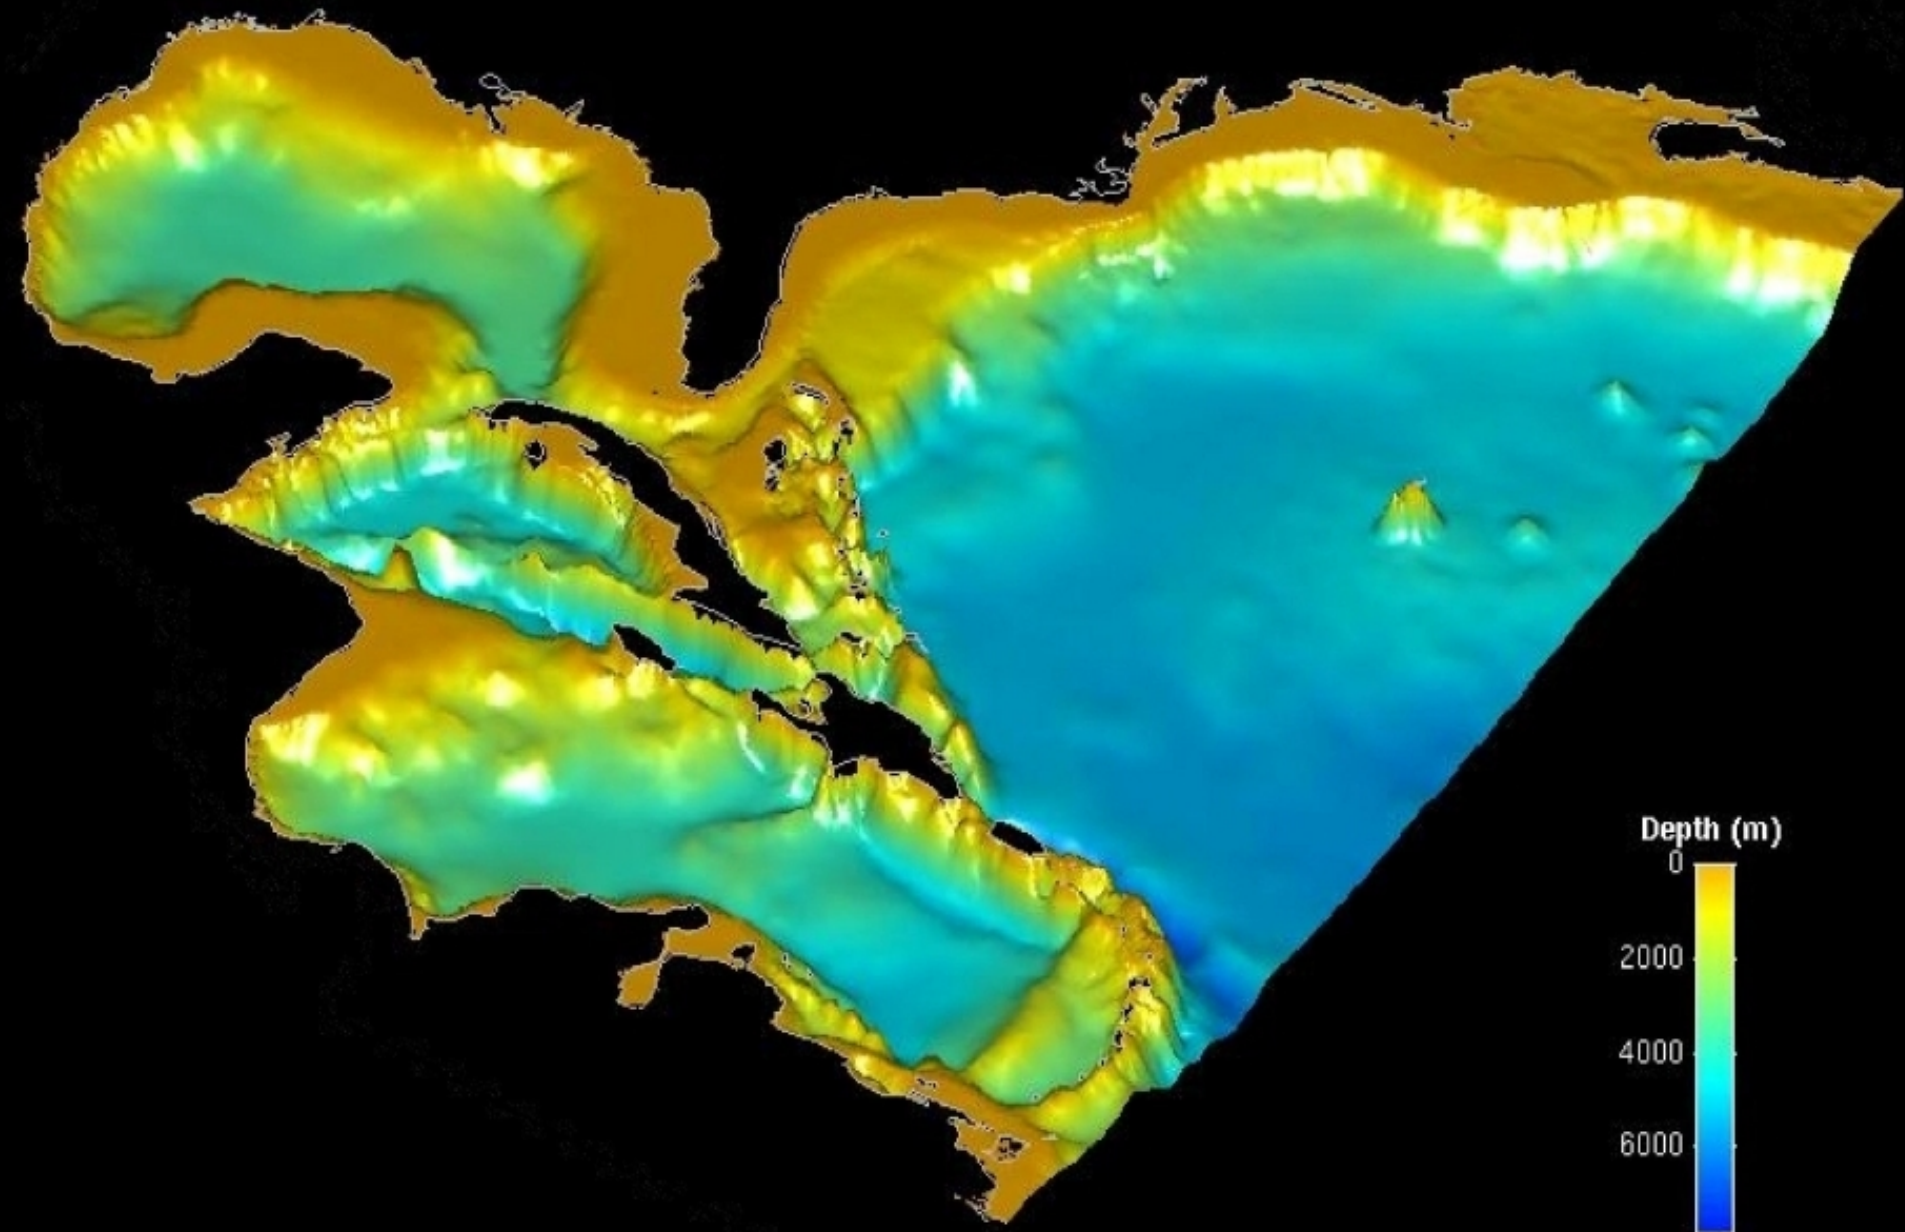
West Atlantic / Gulf Coast ADCIRC Model Domain

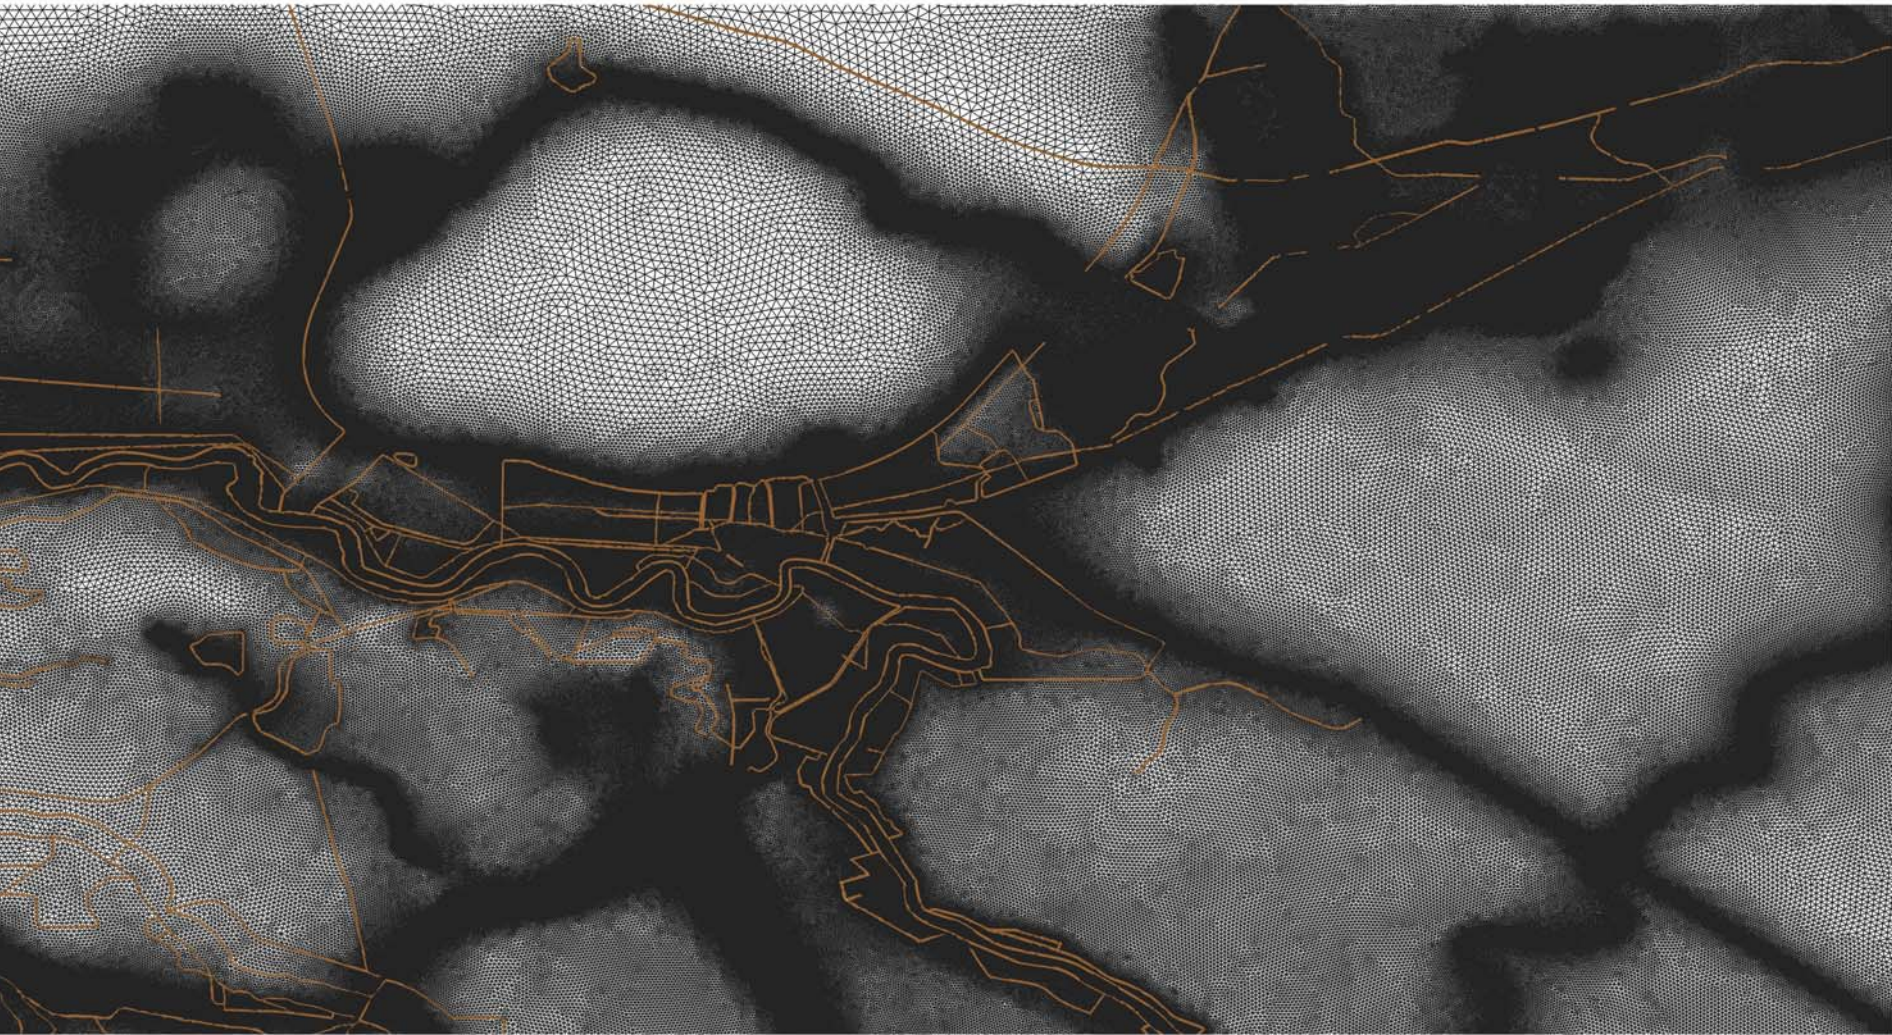
ADCIRC Model Grid for New Orleans, Louisiana
