Acquiring Data and Developing Applications for Coastal Zone Studies and Emergency Response

Gordon Wells

**XIII Brazilian Remote Sensing Symposium
Florianopolis, Santa Catarina, Brazil**

April 25, 2007

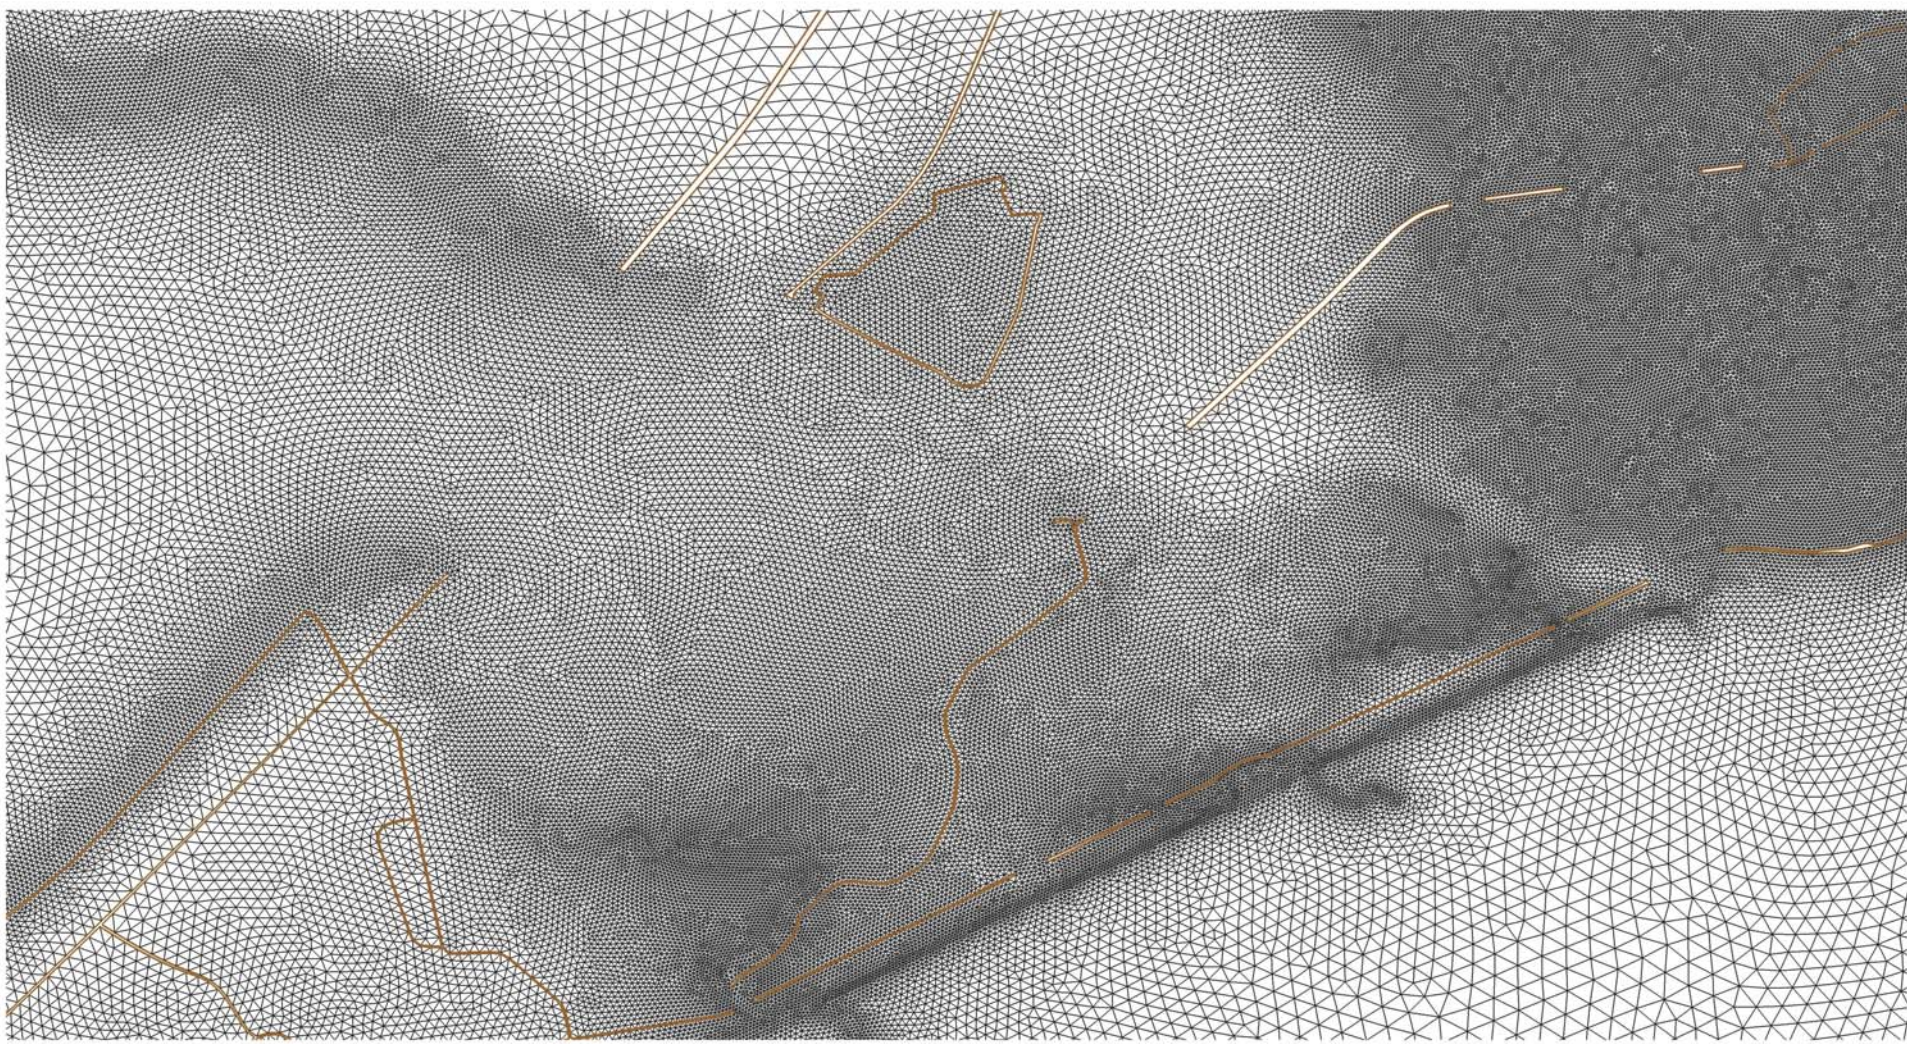
ADCIRC Model Grid for Lake Ponchartrain Outlet

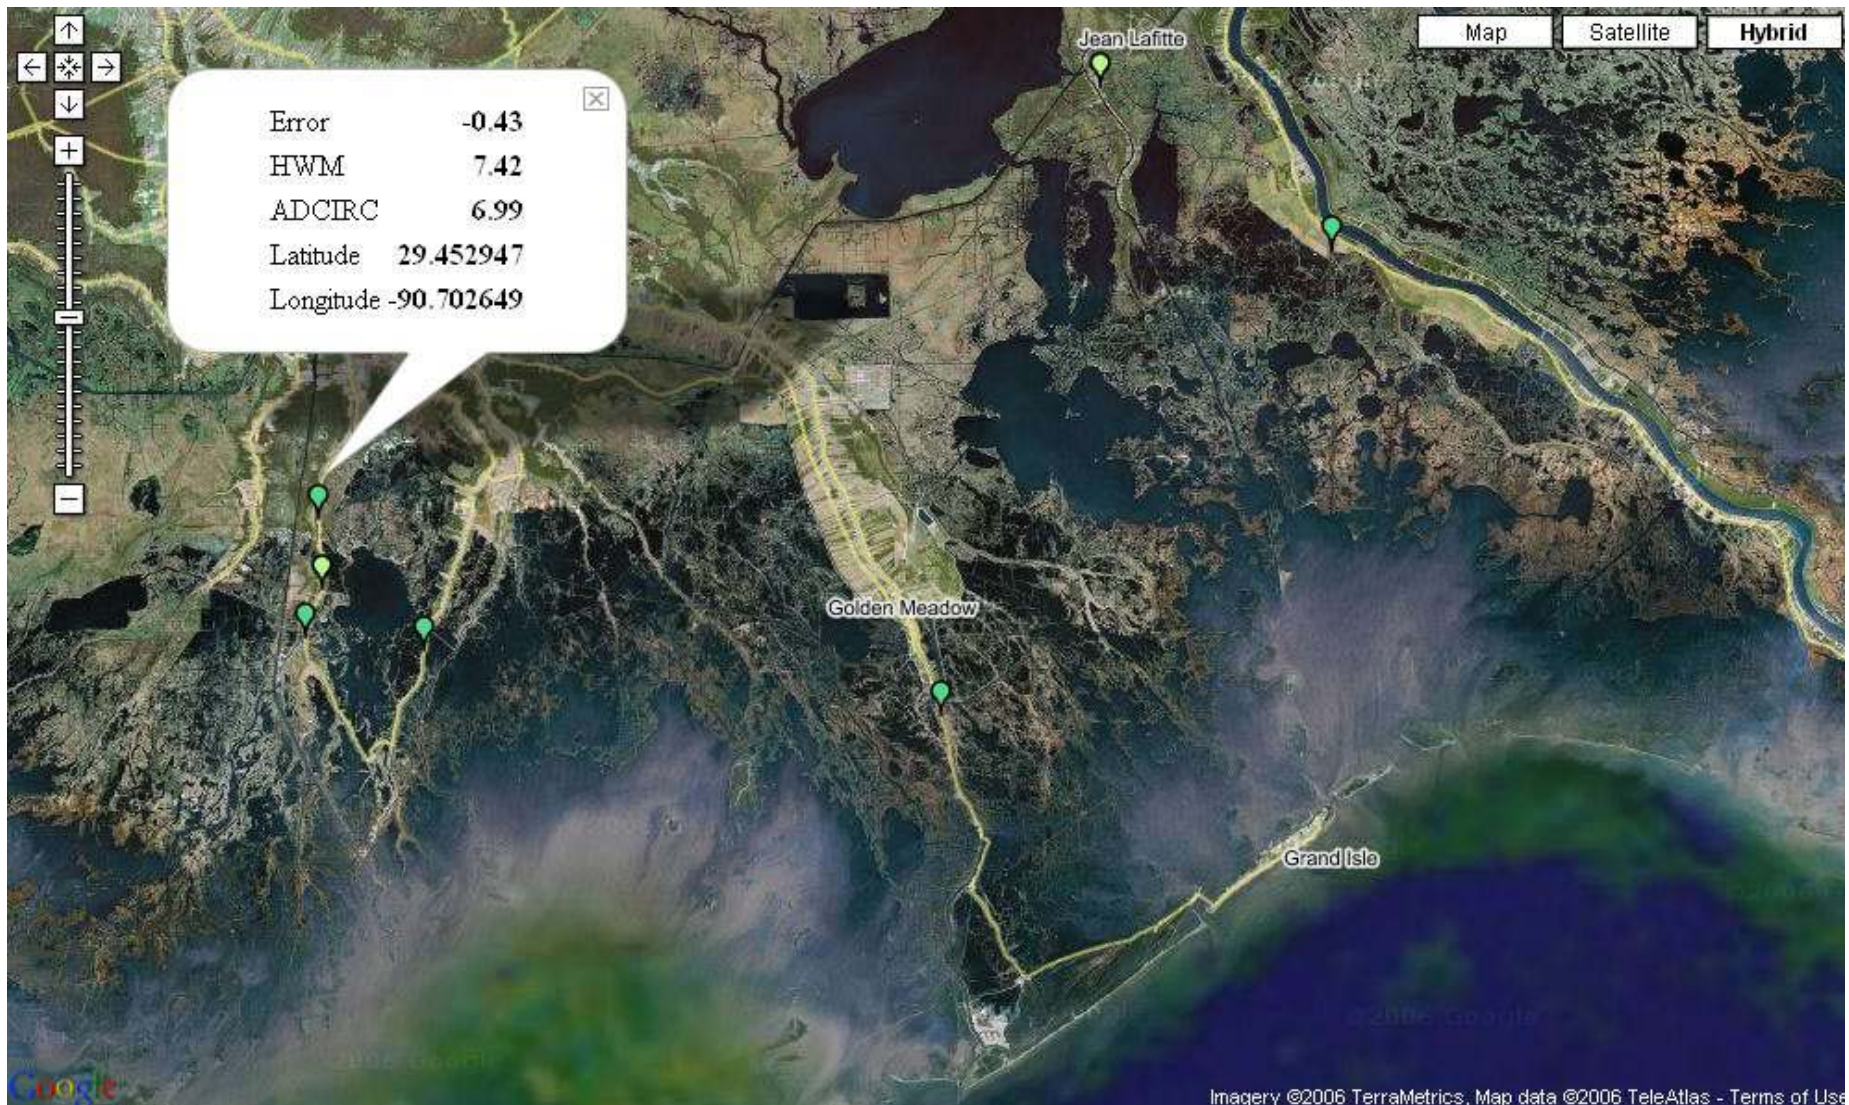
<--Lower -3.0 -1.5 0.0 1.5 3.0 Higher-->

ADCIRC MODEL Validation

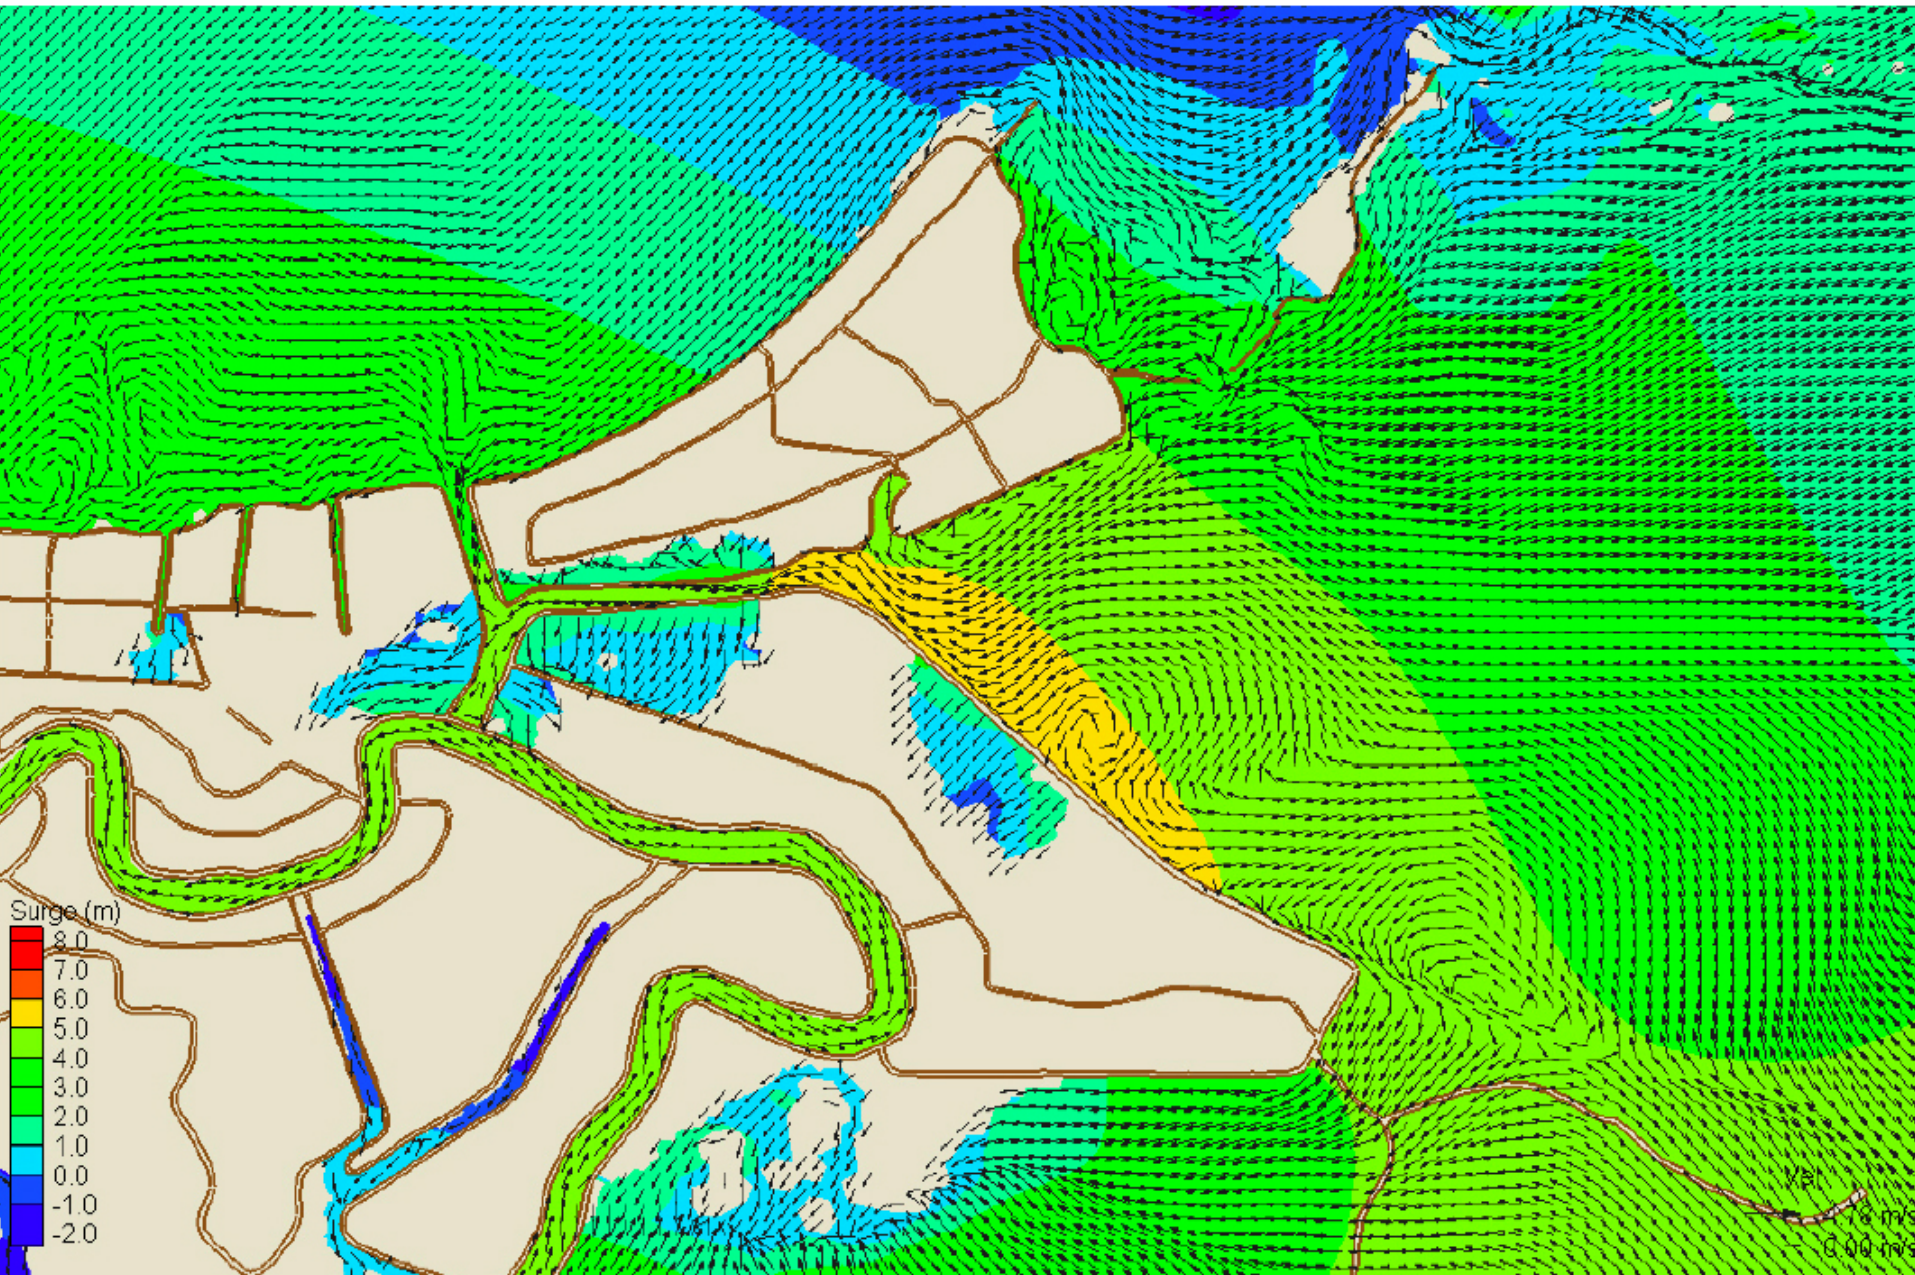
Hurricane Katrina Storm Surge Flow Vectors

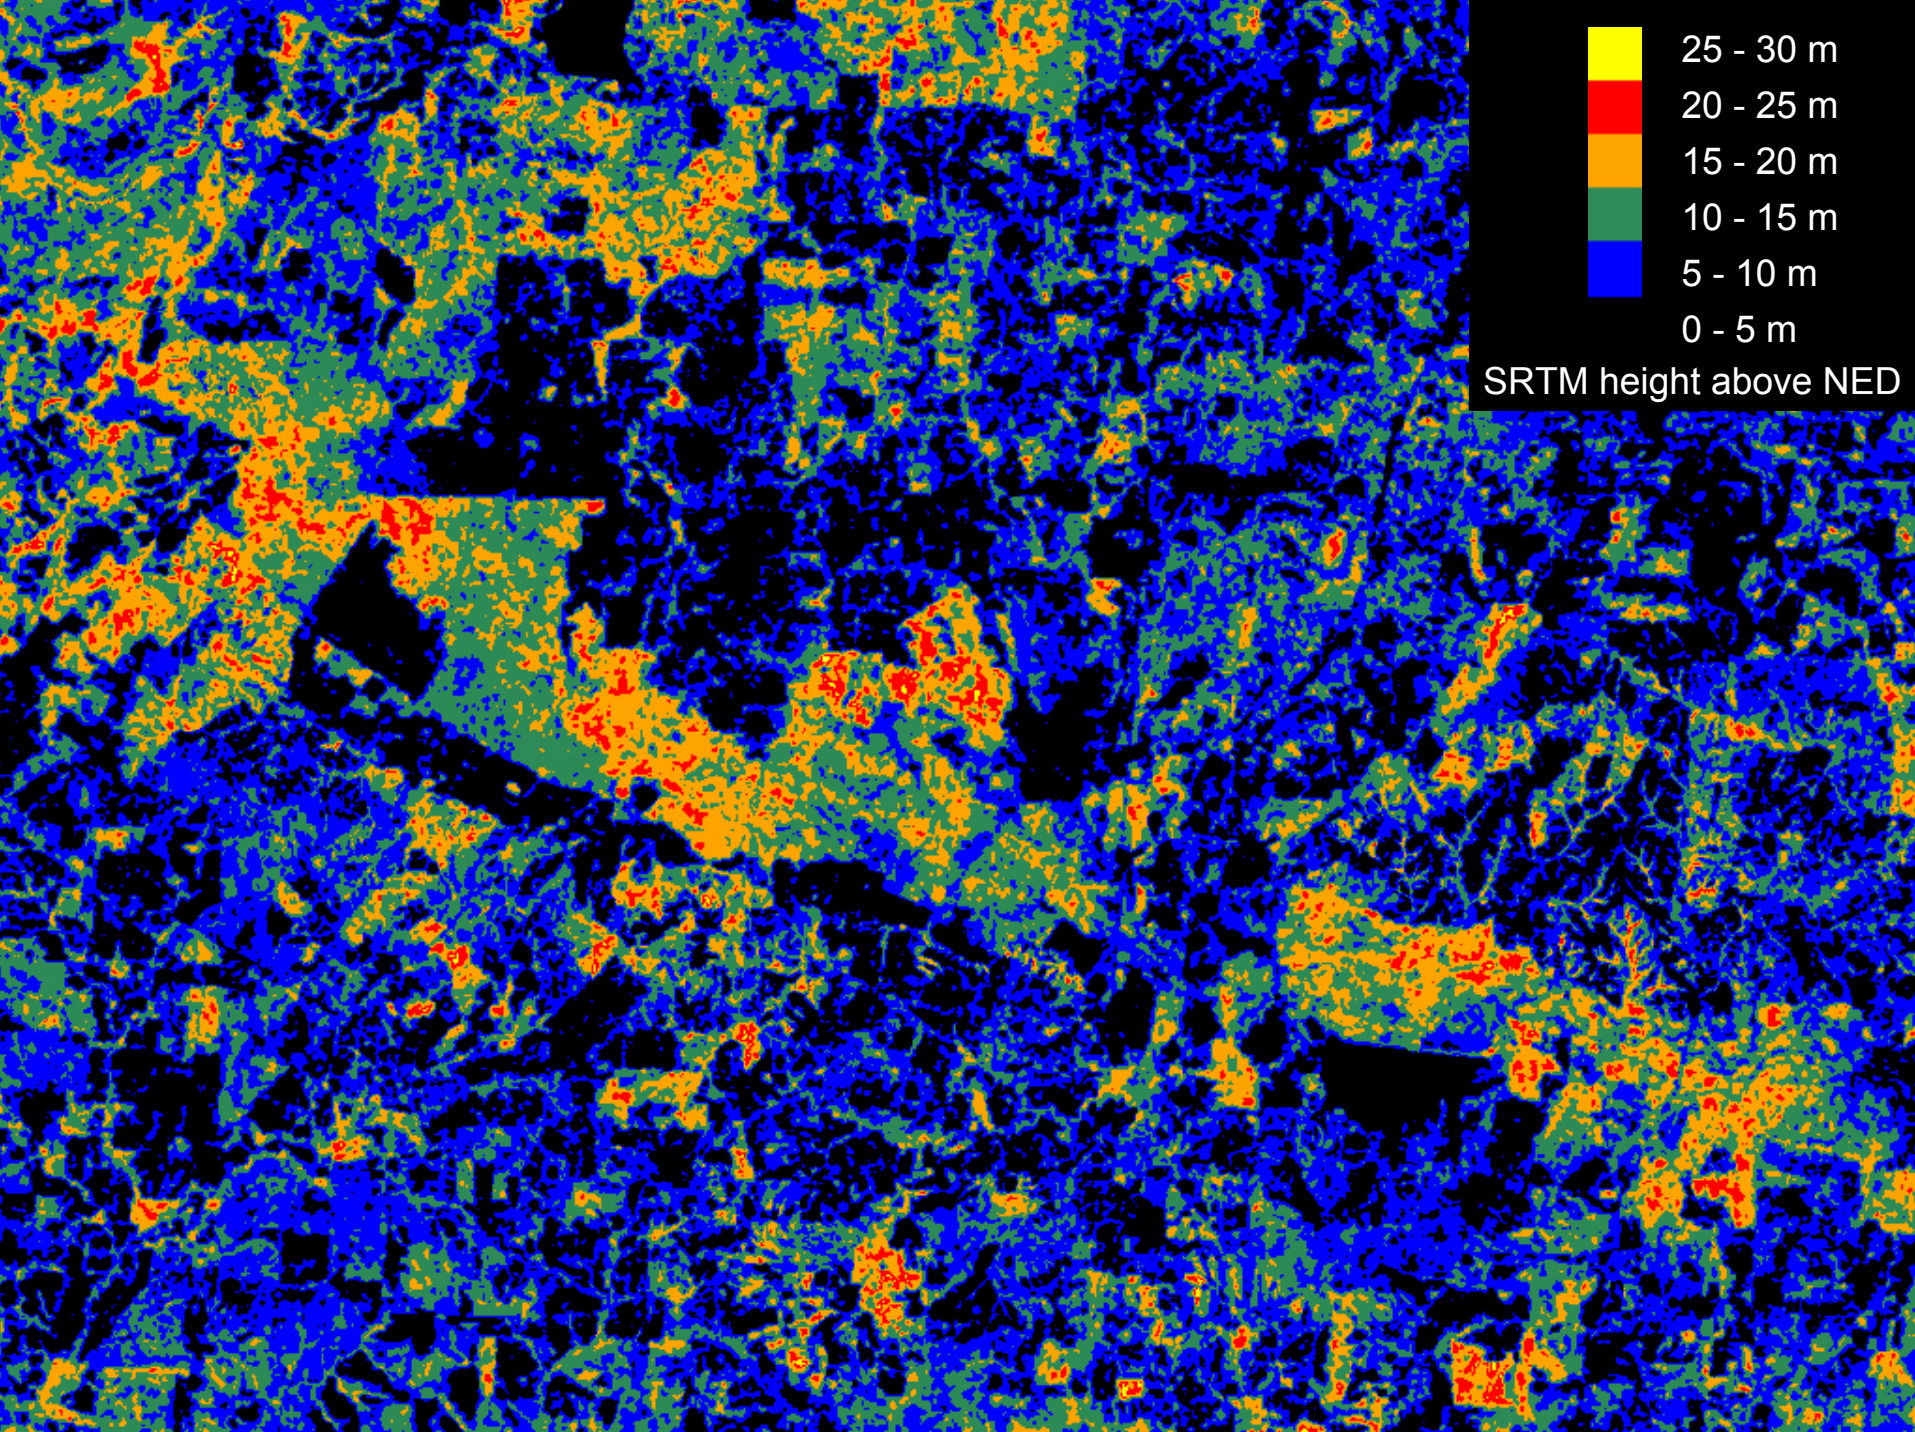
- (A) Hardwoods along the Brazos River
- (B) Older neighborhood with taller trees than adjacent residential areas
- (C) Texas Medical Center
- (D) Riparian corridor

SRTM height above NED

*Vegetation Height
Classification*

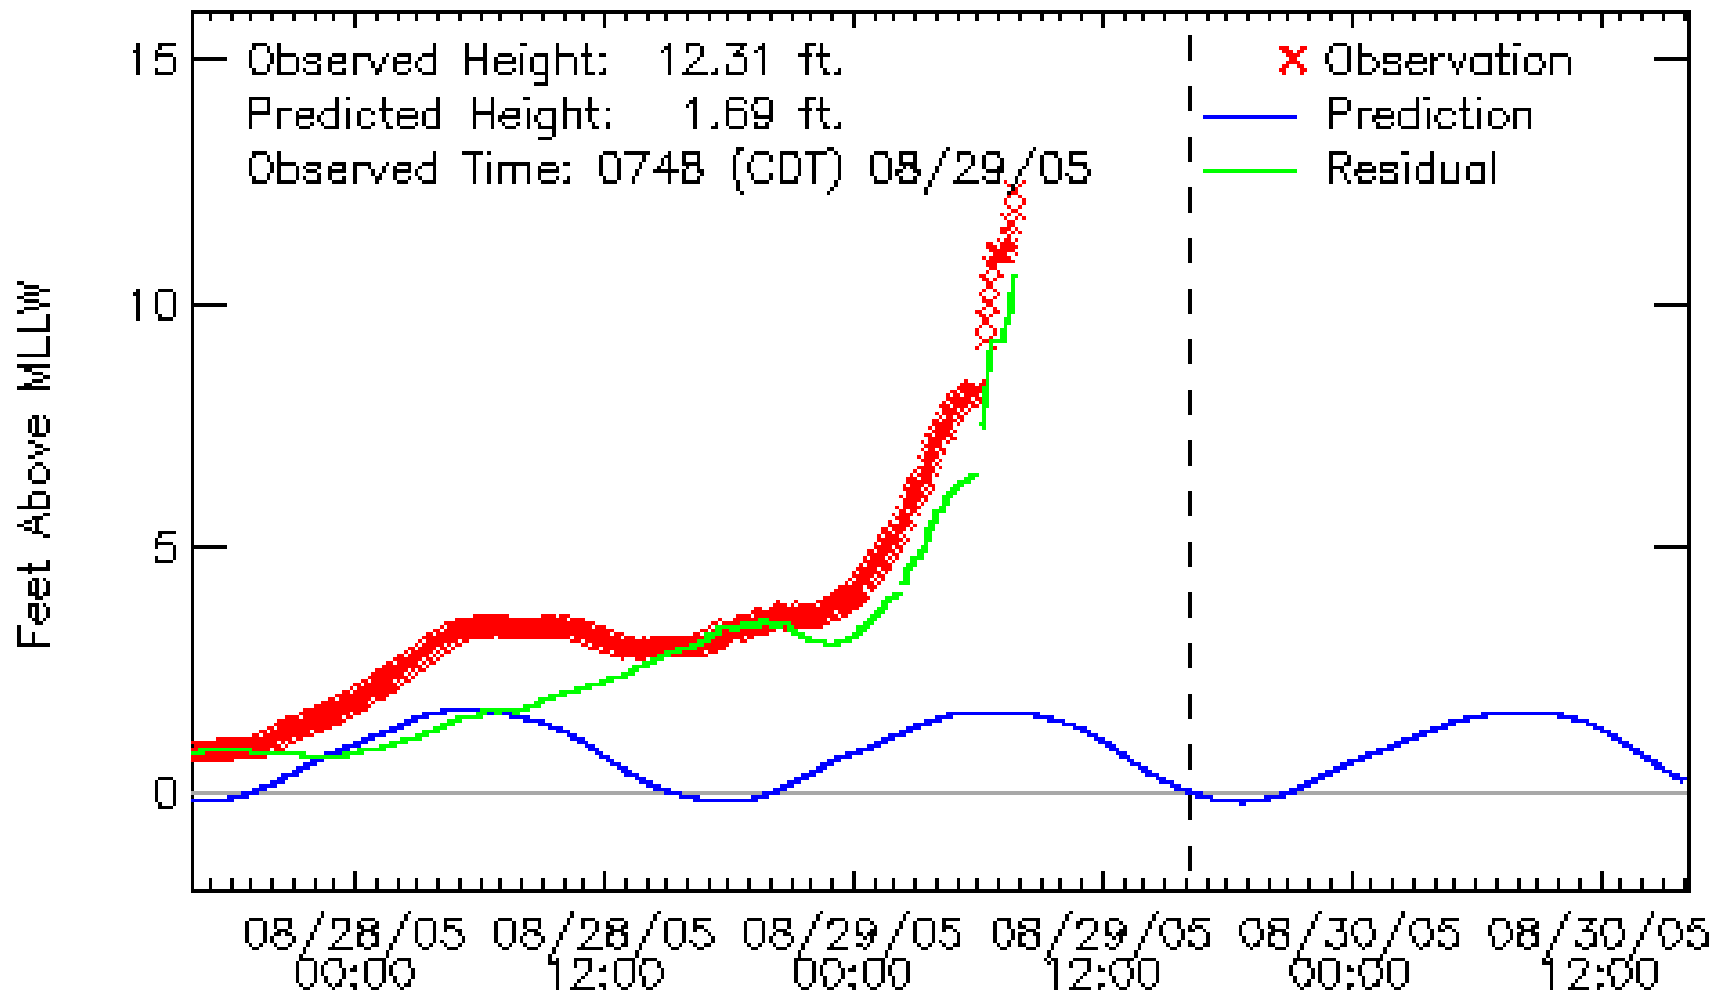
Water Levels

On the morning of August 29, the tidal gauge at Oceans Springs indicated a very large storm surge measured almost four hours before the landfall of Hurricane Katrina. The gauge was destroyed at 7:48 AM CDT.

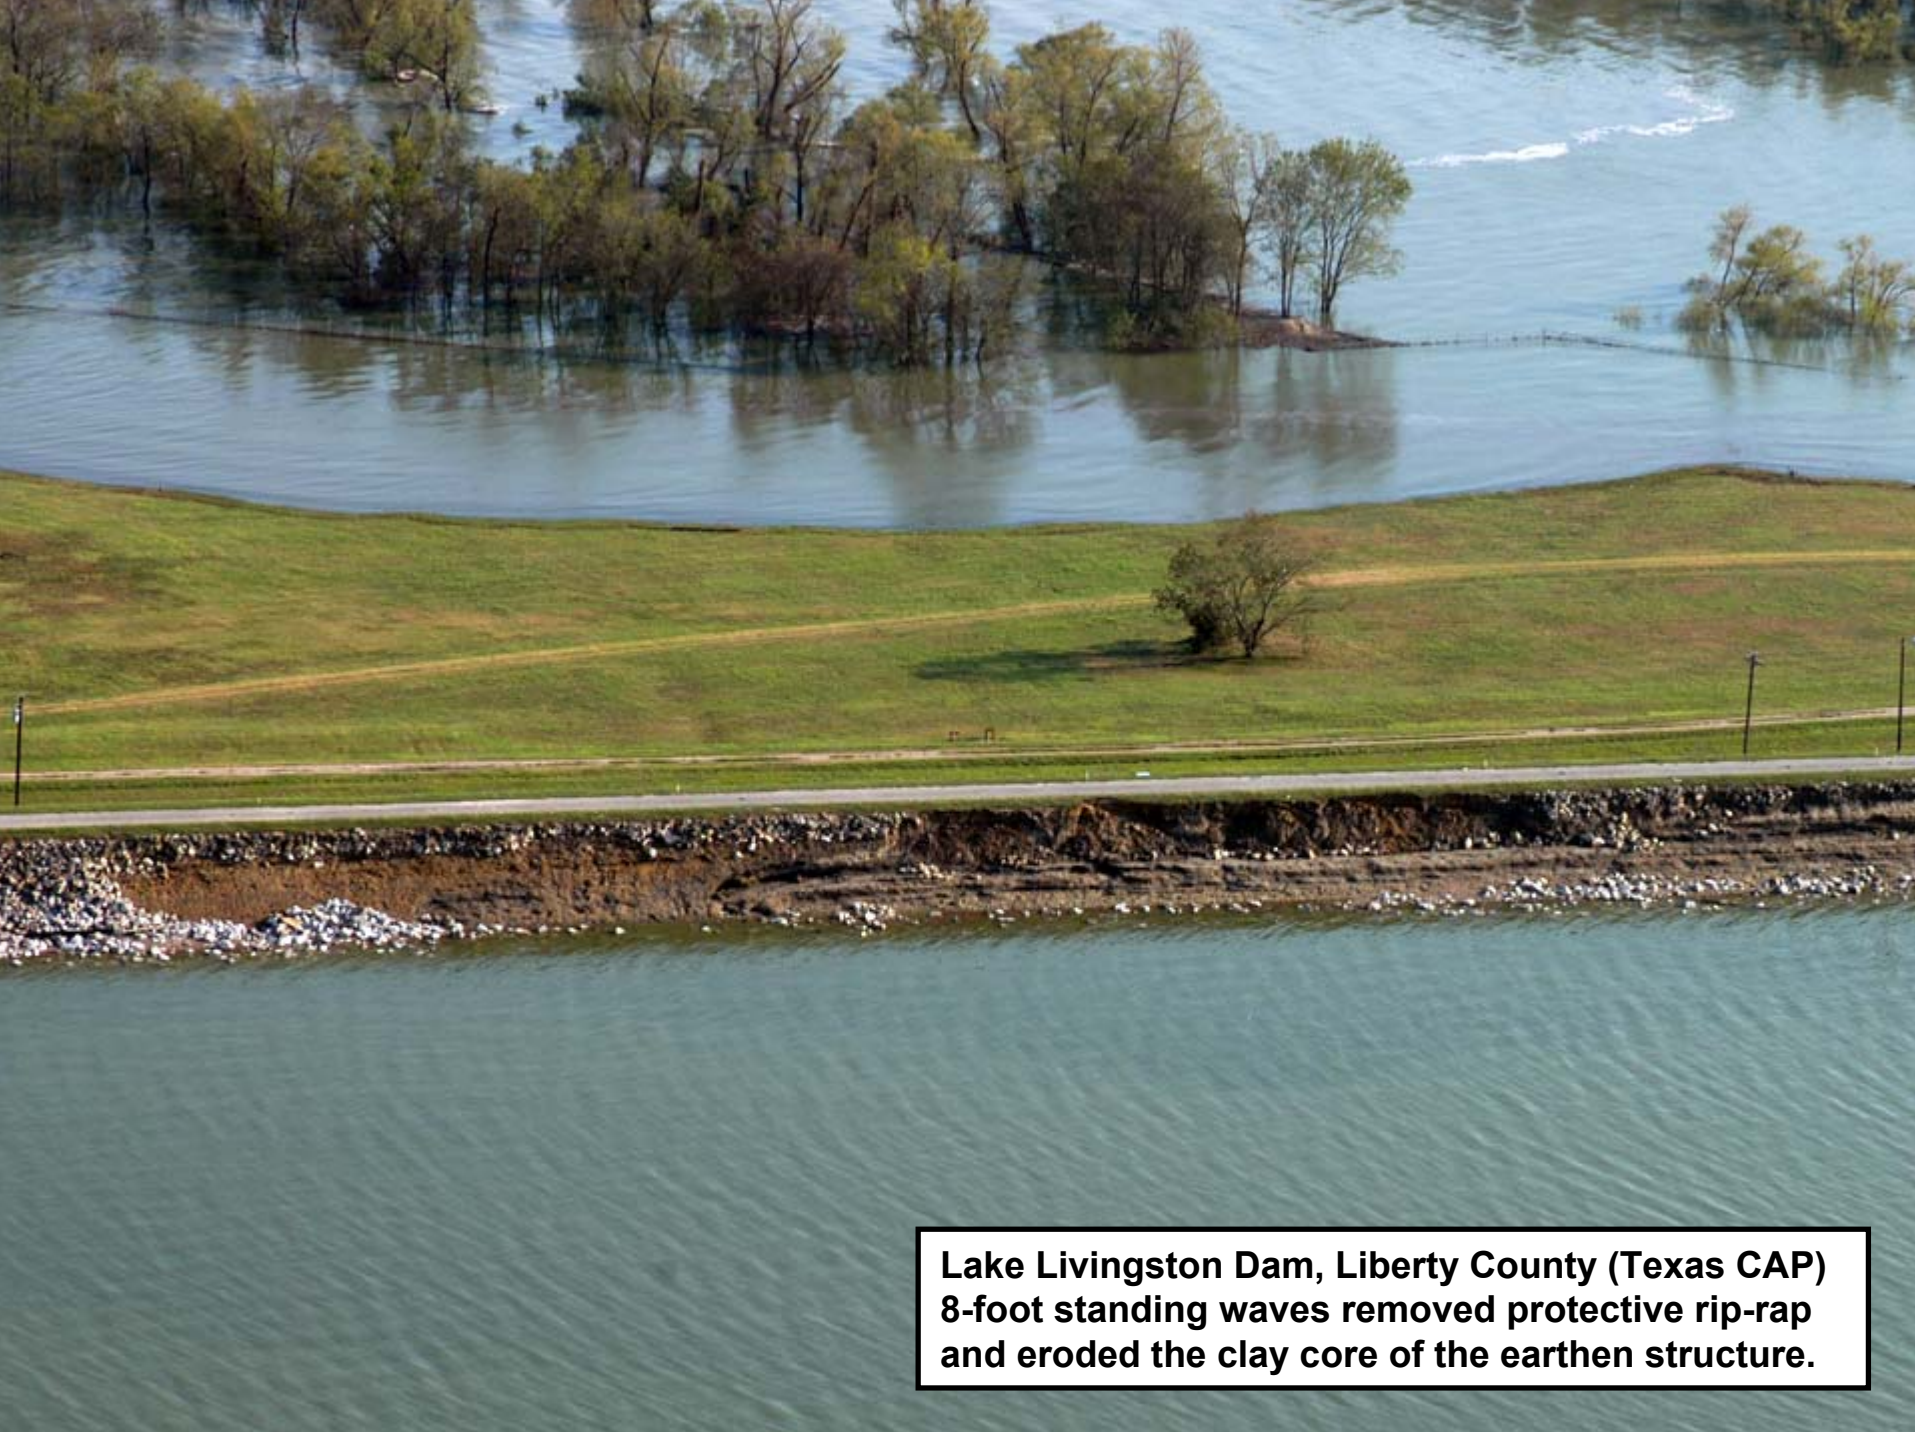
Lake Livingston Dam, Liberty County (Texas CAP)
8-foot standing waves removed protective rip-rap
and eroded the clay core of the earthen structure.
