UPWARD LIGHTNING IN BRAZIL

Marcelo M. F. Saba¹, Jeferson Alves¹, Carina Schumann¹, Diovane R. Campos¹, Tom A. Warner²

1. National Institute for Space Research – INPE – Sao Jose dos Campos, Brazil
2. Dept. of Atmospheric and Environmental Sciences, South Dakota School of Mines and Technology, Rapid City, SD, USA

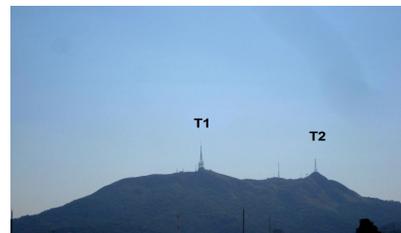
Figure 2 – Jaragua peak in Sao Paulo city and the two main TV towers viewed from where the Photron camera

was placed. The distance between towers T1 and T2 is of 400m.

This peak is located inside the urban area and has two tall TV towers (tower T1 with a height of 136m - 1239 m above sea level - and tower T2 with a height of 90m) and also several other smaller communication towers (Figure 2). Although the high incidence of lightning flashes in the area is not necessarily due to the presence of upward lightning, we took it as a starting point for this study.

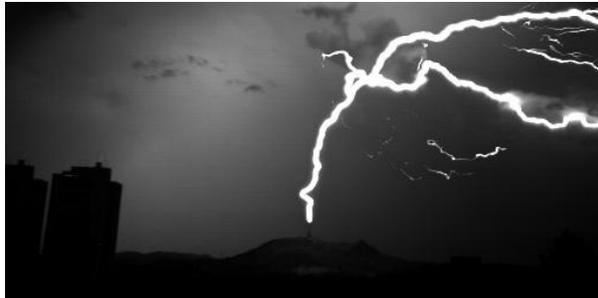
Figure 7 - Time-integrated video segment from the high-speed camera (4.000 ips, 250 μ s exposure) showing the development of bright RLs on the weakly luminous branches. Many of the RLs faded prior to connecting to a main channel.

The time integrated image of the flash time is shown in Figure 7.
